**Re: Property Condition Assessment Report
Former Bix Produce
1415 L'Orient Street
St. Paul, MN 55117
Nova Project No.: W19-7445**

PROPERTY CONDITION ASSESSMENT REPORT

**FORMER BIX PRODUCE
1415 L'ORIENT STREET
ST. PAUL, MN 55117**

NOVA PROJECT NO. W19-7445

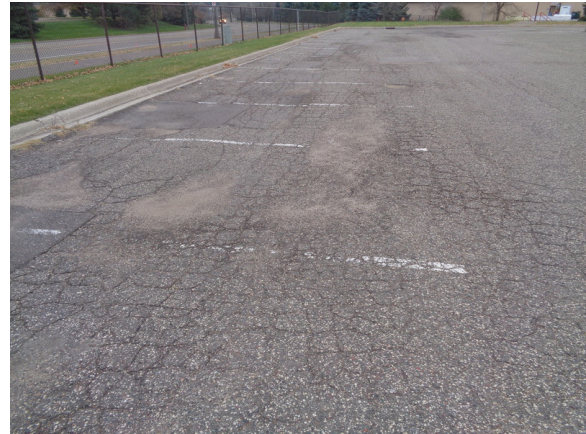
The asphalt pavement has general alligator cracking and deterioration in the sections that are original and installed in 1997. In order to prevent further deterioration, these areas should be milled and overlaid in the short term.

14. Asphalt pavement with alligator cracking, east side of parking area.

COST RECOMMENDATION	EUL	EFF AGE	RUL	YEAR	COST
Asphalt Pavement Recycle	25	24	1	Short Term	\$27,500
Asphalt Seal Coating	5	4	1	Short Term	\$10,500
				5	\$10,500
				10	\$10,500
Total					\$59,000

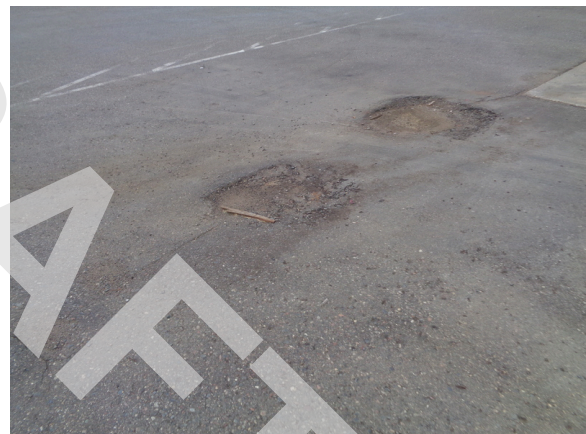
16. Damaged section of asphalt pavement at loading dock.

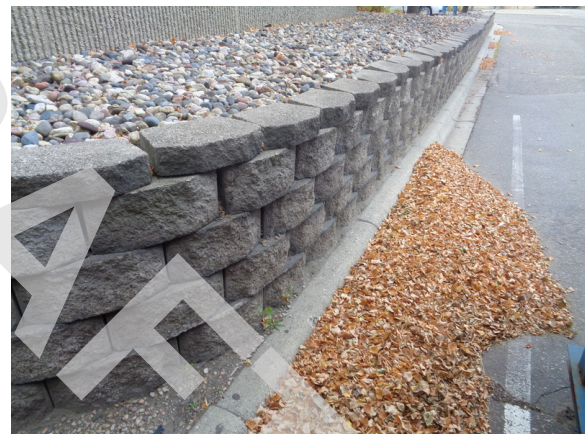
22. CMU retaining wall adjacent to entrance with slight bow.

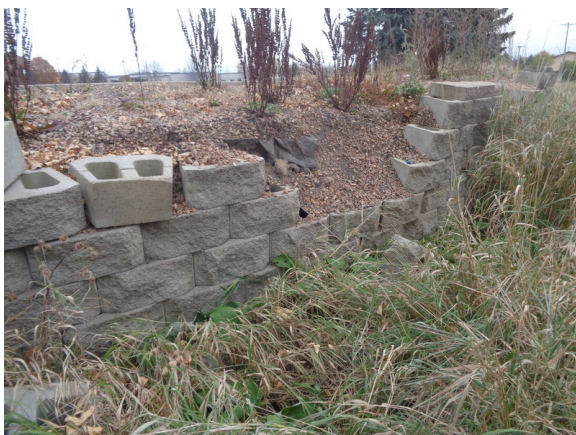
The retaining walls are in in generally good condition, but there are sections at the southwest corner of the site and on the south side of the building that appear to be failing. In order to prevent further deterioration, these sections should be repaired in the Short term.

23. Damaged section of CMU retaining wall, southwest corner of Site.

COST RECOMMENDATION	EUL	EFF AGE	RUL	YEAR	COST
Retaining Wall Masonry Dry Set	-	-	-	Short Term	\$7,500
Total					\$7,500

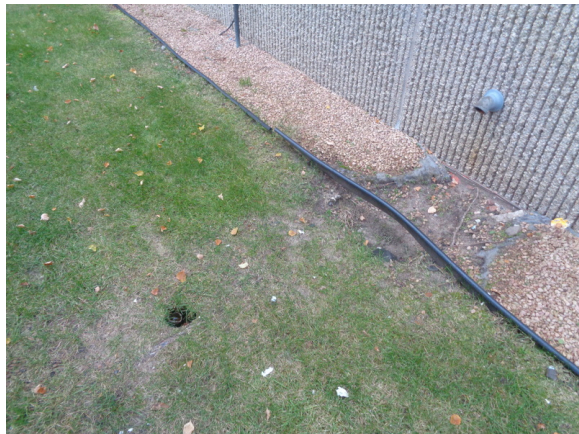
25. Minor erosion on the east side of the building.

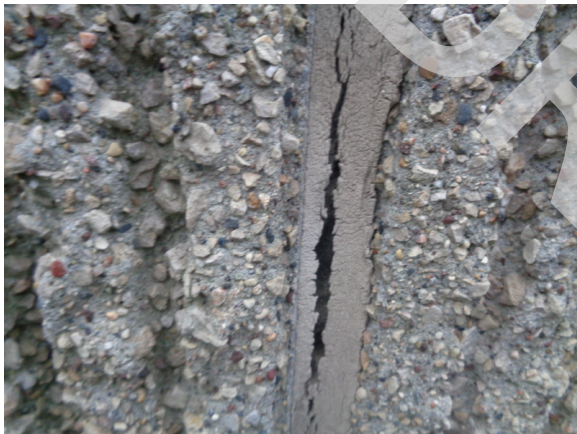
The sealant and caulking was observed to be dry and cracked. In order to prevent water infiltration, the sealants should be replaced in the short term.

33. Cracked sealant at tilt-up concrete panel.

COST RECOMMENDATION	EUL	EFF AGE	RUL	YEAR	COST
Caulking/ Sealants Acrylic Latex	10	9	1	Short Term 10	\$12,600 \$12,600
Total					\$25,200

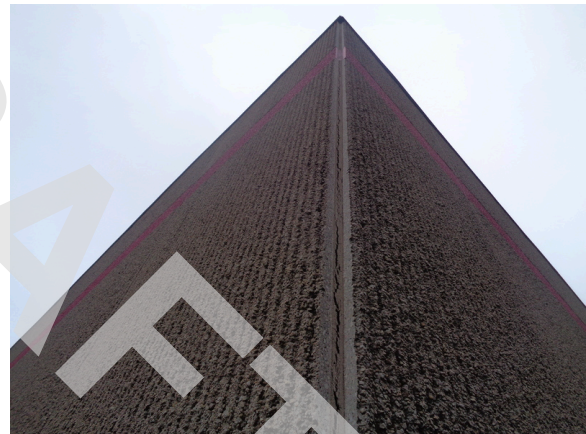
34. Cracked caulking at the northeast corner.

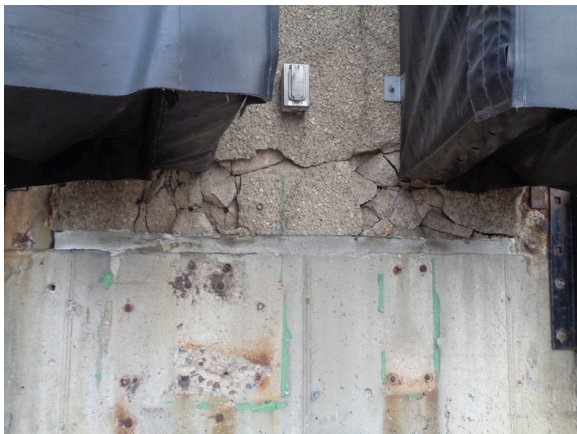
35. Damaged section of precast concrete at loading dock.

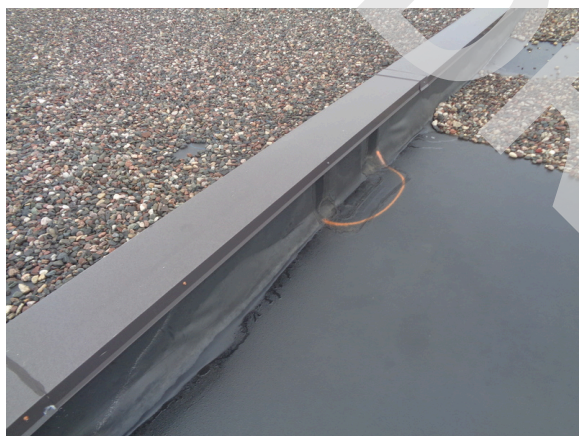
39. EPDM roofing pulling away from parapet.

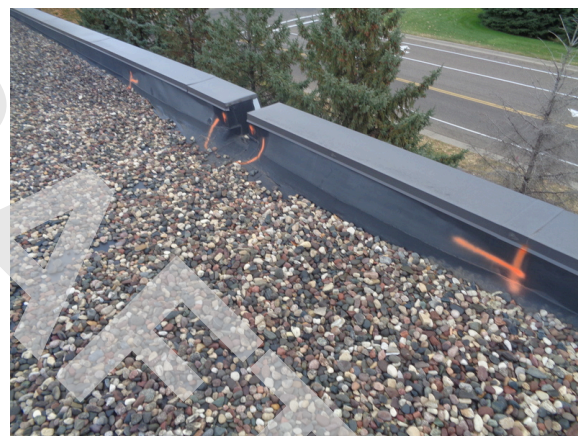
40. Section of EPDM roofing pulling away from parapet.

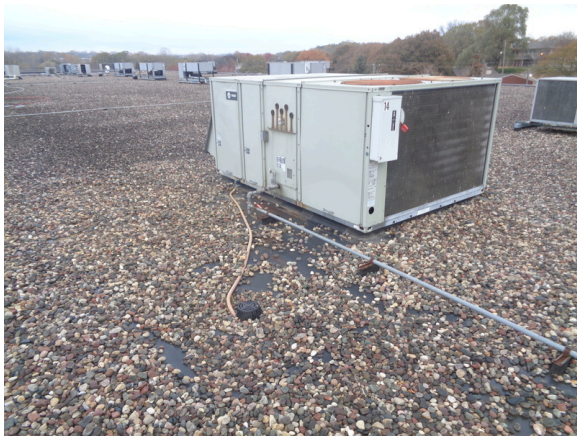
43. Original rooftop packaged HVAC unit.

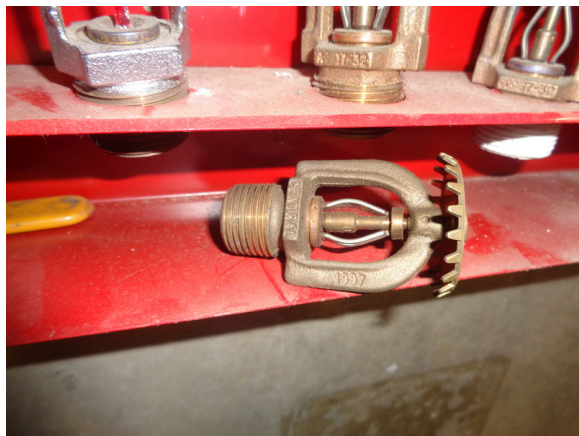
Recalled sprinkler heads were observed. A licensed fire safety professional should survey all sprinkler heads, and develop a plan of correction and replacement as required. An allowance for this investigation has been included to be undertaken immediately, as a life safety issue.

55. Central brand sprinkler head from 1997.

COST RECOMMENDATION	EUL	EFF AGE	RUL	YEAR	COST
Recalled Sprinkler Head Survey	-	-	-	Immediate	\$3,000
Total					\$3,000

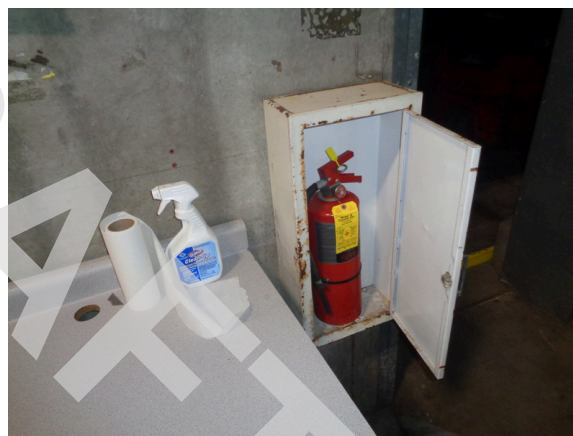
58. Fire extinguisher with expired tag.
