1415 L'ORIENT STREET

Facility + Refrigeration System Assessment

October 29, 2021

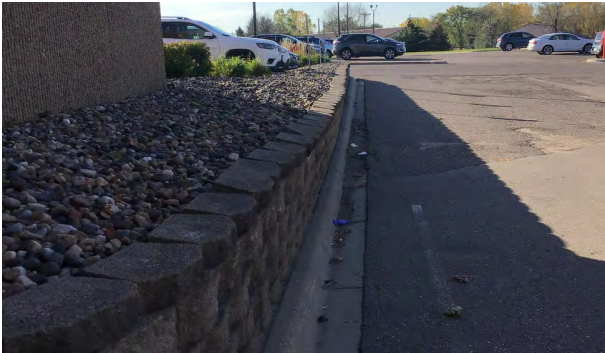
Sub Category	Element	Condition	Priority	Details	Recommendation	Cost Estimate
Grounds + Turf	East Retaining Wall	Poor	I	The retaining wall is significantly curved in the middle section, and slope failure will occur if not corrected.	Remove and replace retaining wall.	\$10,000
Grounds + Turf	West Retaining Wall	Poor	I	The retaining walls have failed and are no longer holding the slopes at all.	Remove and replace retaining wall.	\$14,000
Grounds + Turf	Green-space	Poor	I	Chain-link fence is damaged.	Remove and replace damaged fence posts and chain-link.	\$6,000

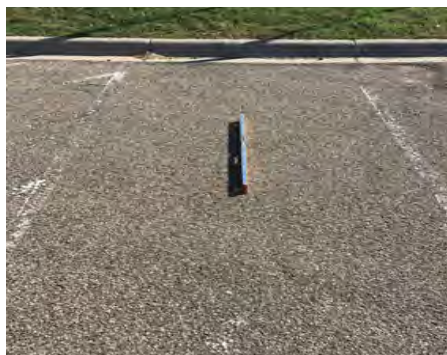
Sub Category	Element	Condition	Priority	Details	Recommendation	Cost Estimate
Vehicle Routes	East Entrance	Poor	1	The accessible parking space had slopes in excess of 2% which is not ADA compliant. The parking area in front of the entrance does not drain properly.	Mill and overlay parking lot pavement to repair slopes and improve drainage.	\$11,200
Vehicle Routes	Catch Basin	Fair	2	The catch basin still has inlet protection installed and does not drain properly through the system.	Remove inlet protection.	\$340
Vehicle Routes	Parking Lot	Poor	1	The employee parking lot has alligator cracking in multiple locations and previous patches and crack fills that have failed. There are multiple wheel indents which indicates subbase issues.	Replace the full depth of the pavement section.	\$362,000
Vehicle Routes	Parking Lot	Fair	2	Cracked curb panels.	Remove and replace cracked curb panels.	\$1,400
Vehicle Routes	Parking Lot	Fair	2	Bituminous pavement requires maintenance every 4 years. This budget item is for the first four years.	Crack fill, seal coat, and stripe parking lot.	\$37,100

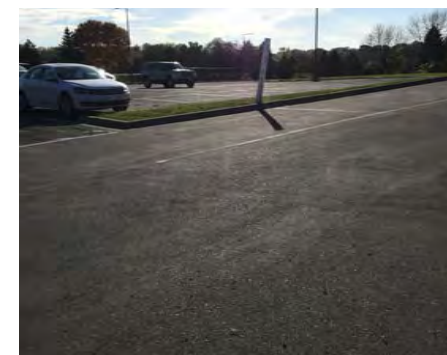
Bituminous Pavement

Vehicle Routes	Parking Lot	Fair	3	Bituminous pavement requires maintenance every 4 years. This budget item is for the second four years.	Crack fill, seal coat, and stripe parking lot.	\$66,500

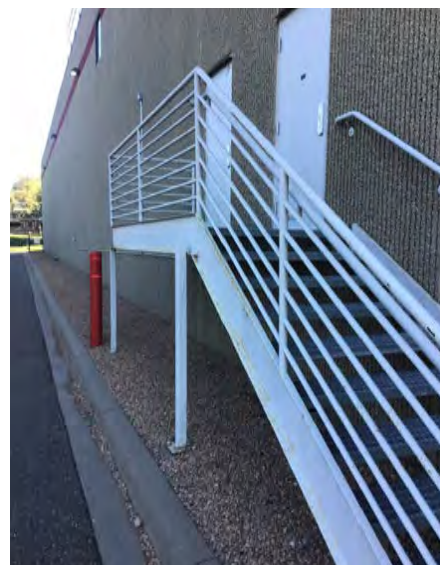
Other Site Civil	West Stairs	Fair	3	Stairs have developed rust due to exposure.	Paint stairs to prevent further rusting.	\$670
Site Subtotal						\$437,110

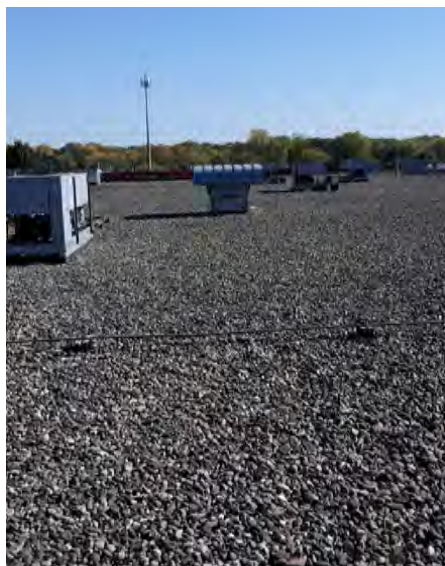
Sub Category	Element	Condition	Priority	Details	Recommendation	Cost Estimate
Exterior Roof	Original 1996 Building Roof	Poor	1	The existing roof is an EPDM ballasted system. The installation date is unknown, but believed to be original to the 1996 construction. The estimated useful life of the roof is 20 years. There are areas of steel roof deck material that are severely rusted. The condition of the insulation is unknown.	Replace the roof and rusted portions of steel deck. Replace roof insulation in areas of deck replacement.	\$1,700,000
Exterior Roof	2006 Addition Building Roof	Good	2	The existing roof is an EPDM ballasted system. The installation date is 2006. The estimated useful life of the roof is 20 years.	Replace the roof in the next 5-10 years.	\$530,000
Exterior Roof	Roof Hatch	Poor	1	There is no fall protection around the hatch and two pieces of equipment on the roof. This is an OSHA violation.	Install fall protection.	\$6,000

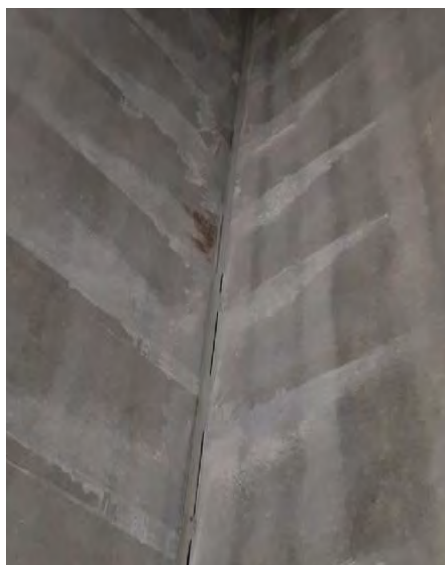
Exterior Walls	Exterior Sealants	Poor	1	The original building is constructed using precast concrete panels. There is a sealant between each panel. The sealants have failed.	Remove and replace exterior wall panel sealants.	\$28,000
Exterior Walls	Interior Wall Sealant	Poor	1	Sealants on the interior side of exterior precast concrete panels have failed in several locations.	Remove and replace failed sealants.	\$1,500
Exterior Walls	Loading Dock Precast Walls	Poor	1	The precast walls under several loading dock doors are damaged.	Remove any loose material and infill damaged areas with concrete.	\$10,000
Exterior Windows	Exterior Windows	Good	3	Windows are aluminum framed, double pane glass. They are located in the office and lab areas of the building.	Perform regular maintenance.	\$0

Cracks in Sealant

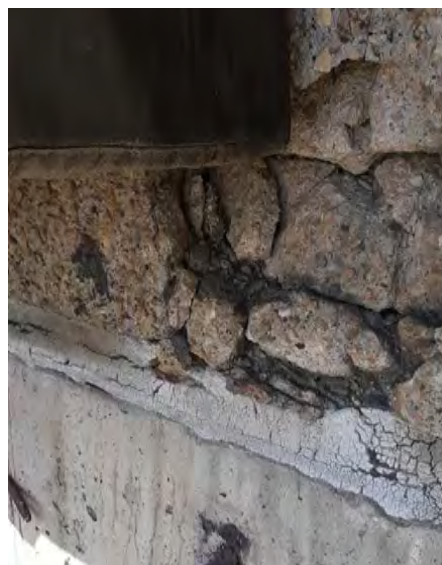
Precast Wall Damage

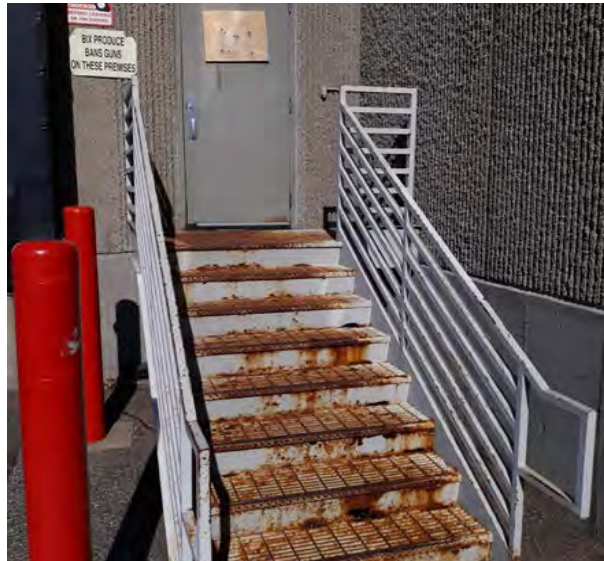
Metal Stairs

Exterior Other	Exit Stairs	Poor	I	The metal stairs at the loading dock exit are rusted and have holes in the risers.	Replace the metal stairs.	\$10,000

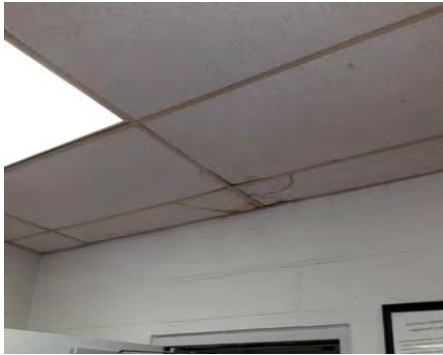
Acoustical Ceiling Tile

Sub Category	Element	Condition	Priority	Details	Recommendation	Cost Estimate
Interior Ceiling	Office Area	Poor	1	The acoustical ceiling tiles are outdated. Several are damaged or missing. Many tiles around diffusers appear dirty.	Replace acoustical ceiling tiles.	\$39,600
Interior Ceiling	Breakroom/Employee Restrooms	Poor	1	The acoustical ceiling tiles are outdated. Several are damaged or missing. Many tiles around diffusers appear dirty.	Replace acoustical ceiling tiles.	\$9,600
Interior Ceiling	Bar Joist in Raw Cooler Room	Poor	1	The bar joist is heavily rusted.	Remove rust from bar joist system. Coat ceiling deck and bar joist system.	\$154,000
Interior Ceiling	Bar Joist in Wet Cooler and West Cooler Rooms	Fair	2	The bar joist is moderately rusted in wet cooler and west cooler room.	Remove rust from bar joist system. Coat ceiling deck and bar joist system.	\$373,000
Interior Ceiling	Bar Joist in Dry Cooler	Fair	2	The bar joist is lightly rusted.	Remove rust from bar joist system. Coat ceiling deck and bar joist system.	\$90,500

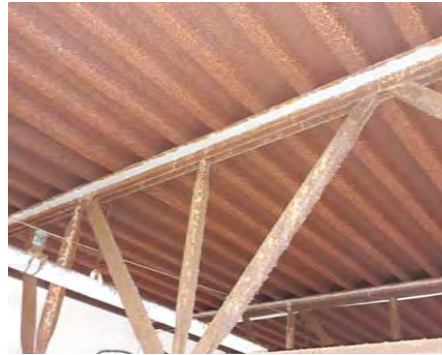
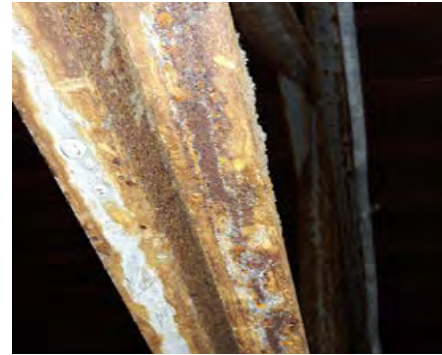
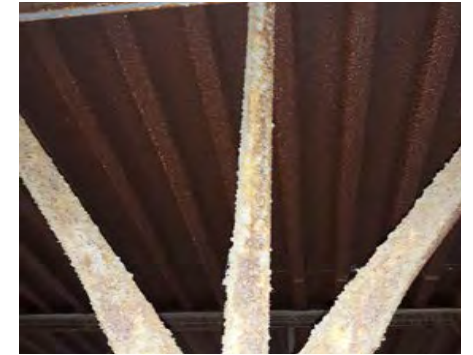
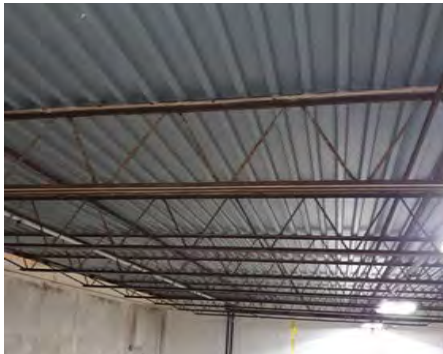
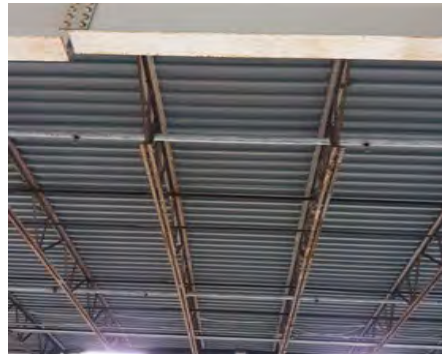
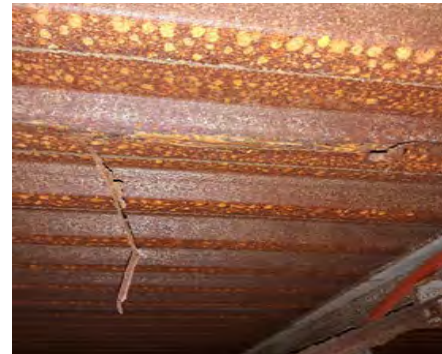
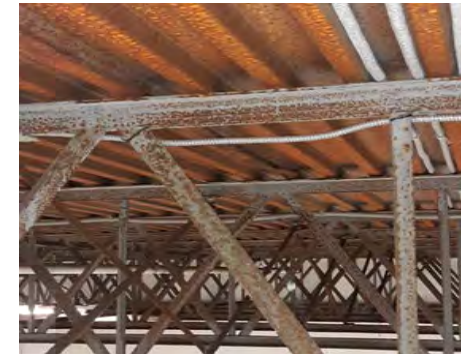
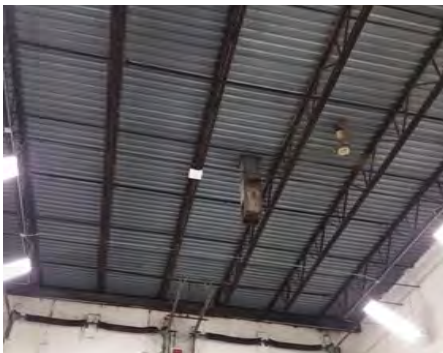
Interior Ceiling	Bar Joist in Food Waste Containers Room	Fair	2	The bar joist is moderately rusted.	Remove rust from bar joist system. Coat ceiling deck and bar joist system.	\$37,300
Interior Ceiling	Mezzanine Suspended Ceiling	Fair	1	The suspended ceiling, over the processing room is attached at the bottom of the bar joist.	Conduct a structural review to determine if bar joist are rated for this type of installation. Cost is for structural analysis.	\$4,000

Rusted Bar Joist

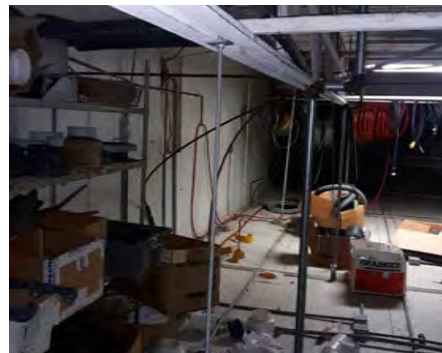
Suspended Ceiling Supports

Interior Ceiling	Mezzanine Suspended Ceiling	Fair	I	The suspended ceiling, over the processing room, is attached at the bottom of the bar joist.	Conduct a structural review to determine if bar joist are rated for this type of installation. Cost is for structural analysis.	\$4,000
Interior Walls	Office Area	Poor	I	The walls are damaged in several locations. Water staining is present in office restrooms. The wallpaper is peeling in some of the offices and hallways.	Repair damaged walls. Refinish wall coverings. Install additional wall tile in restrooms.	\$20,000

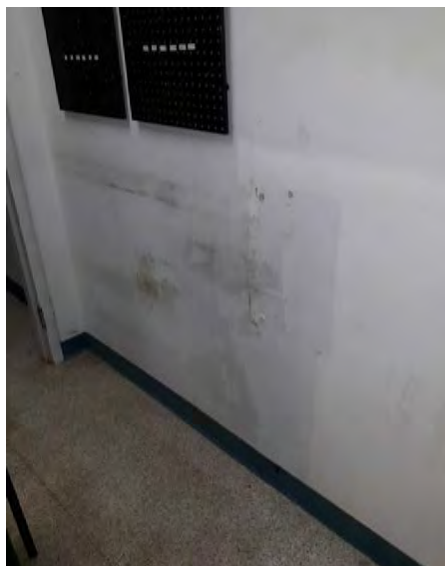
Sub Category	Element	Condition	Priority	Details	Recommendation	Cost Estimate
Interior Walls	Office Area	Poor	1	The walls are damaged in several locations. Water staining is present in office restrooms. The wallpaper is peeling in some of the offices and hallways.	Repair damaged walls. Refinish wall coverings. Install additional wall tile in restrooms.	\$20,000
Interior Walls	Chemical Storage Room	Poor	1	The metal wall panels are rusted.	Replace damaged wall panels.	\$4,000
Interior Walls	West Cooler Sealant	Poor	1	The interior floor sealant at the exterior wall has failed or is missing in places.	Remove and replace the sealant along the exterior wall.	\$1,600
Interior Floors	Office Area	Poor	1	The carpet in the office area is heavily soiled in the lower level. The adhesive under the carpet has failed in many areas.	Replace the carpet.	\$39,600
Interior Other	Office Area Restrooms	Poor	1	Plumbing under sinks does not have pipe wrap installed so is not ADA compliant.	Install ADA compliant pipe wrap.	\$500

Wall Damage

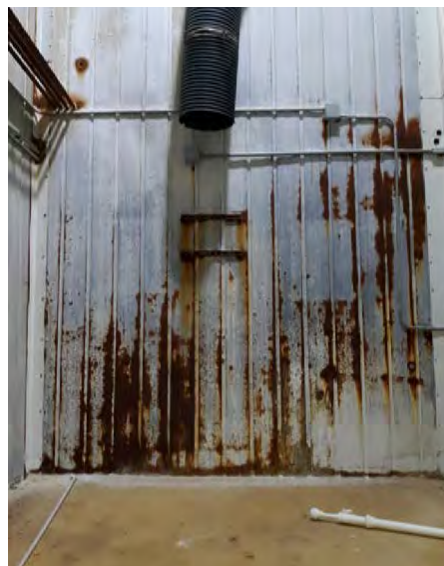
Interior Walls	Chemical Storage Room	Poor	I	The metal wall panels are rusted.	Replace damaged sections of wall panels.	\$4,000
Interior Walls	West Cooler Sealant	Poor	I	The interior floor sealant at the exterior wall has failed or is missing in places.	Remove and replace the sealant along the exterior wall.	\$1,600
Interior Floors	Office Area	Poor	I	The carpet in the office area is heavily soiled in the lower level. The adhesive under the carpet has failed in many areas.	Replace the carpet.	\$39,600
Interior Other	Office Area Restrooms	Poor	I	Plumbing under sinks does not have pipe wrap installed so is not ADA compliant.	Install ADA compliant pipe wrap.	\$500
Exterior Roof	2006 Addition Building Roof	Good	2	The existing roof is an EPDM ballasted system. The installation date is 2006. The estimated useful life of the roof is 20 years.	Replace the roof in the next five to ten years.	\$530,000
Exterior Doors	Employee Entrance	Fair	2	Door and windows are aluminum framed, double paned glass. The door is rubbing on frame.	Adjust door.	\$200

Rusted Wall Panel

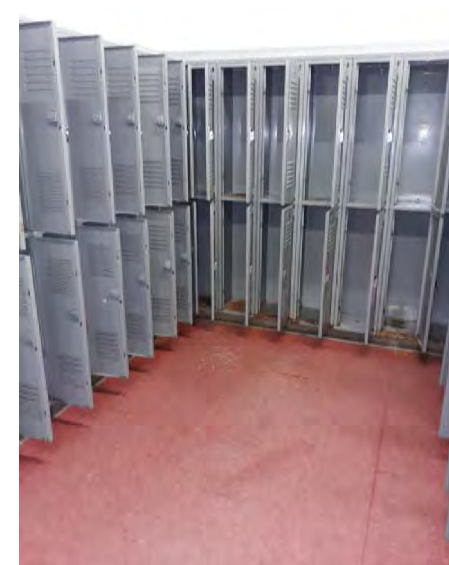
Interior Other	Locker Room Lockers	Poor	2	Several of the lockers have substantial rust. Some of the locker floors have holes in them.	Replace locker room lockers.	\$55,000

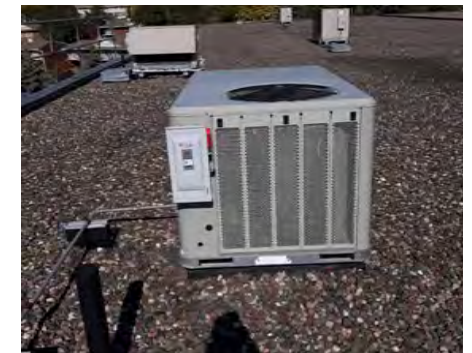
Rooftop Unit

Heating Cooling	RTU #14	Fair	2	The rooftop unit serving the dry storage room is a Trane brand, package heating and cooling unit. It was installed in 1997. The average useful life of a rooftop unit is 20 years.	Replace RTU #14.	\$40,000
Heating Cooling	RTU #15 and #16	Good	3	The Carrier brand units serving the office area are package heating and cooling units. They were installed in 2014. The average useful life of a rooftop unit is 20 years.	Perform regular maintenance.	\$0
Heating Cooling	Production Office Condensing Unit	Poor	1	The condensing unit located on the roof appears to be original to the building. The average useful life is 20 years.	Replace condensing unit.	\$4,000
Heating Cooling	RTU #30	Fair	2	The unit is a 7.5-ton, Carrier brand package heating and cooling unit. It was installed in 2006. The average useful life of a rooftop unit is 20 years. One of the service panels has been blown off by wind and is laying next to the building.	Reinstall service panel. Replace RTU #30 in the next five years.	\$26,600

Heating Cooling	RTU #31 and #32	Fair	2	The Trane brand units are package heating and cooling units. It is unknown when they were installed but appears to have been in 2006. The average useful life of a rooftop unit is 20 years.	Replace RTU #31 and #32 in the next five years .	\$60,000

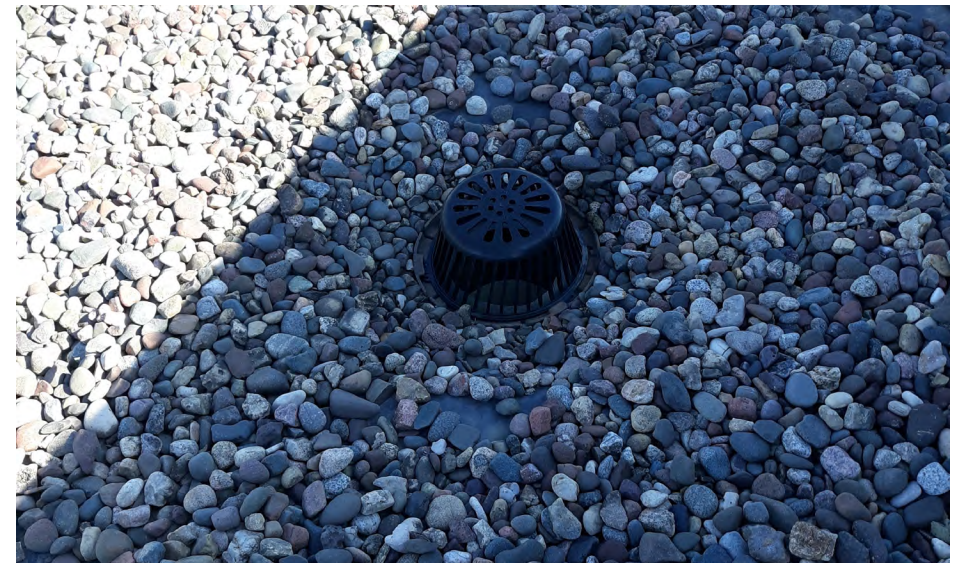
Roof Drain

Sub Category	Element	Condition	Priority	Details	Recommendation	Cost Estimate
Plumbing Water	Locker Room Water Heater	Fair	2	The water heater is 40-gallon, electric unit. It was installed in 2010. Average useful life is 15 years.	Replace water heater.	\$1,600
Plumbing Water	Furnace Room Tankless Water Heater	Fair	2	The Rheem brand tankless water heater was installed in 2015. Average useful life of tankless water heaters is 10 years.	Replace water heater in the next three to five years.	\$2,800
Plumbing Water	Office Area Water Heater	Good	3	The water heater is a 50-gallon, electric unit. It was installed in 2017. The average useful life is 15 years.	Perform regular maintenance.	\$0
Other Plumbing	Original Building Secondary Roof Drains	Poor	I	There are no secondary roof drains on this portion of the roof.	Install secondary roof drains.	\$21,300
Other Plumbing	2006 Addition Secondary Roof Drains	Poor	I	There are no secondary roof drains on this portion of the roof.	Install secondary roof drains.	\$19,300

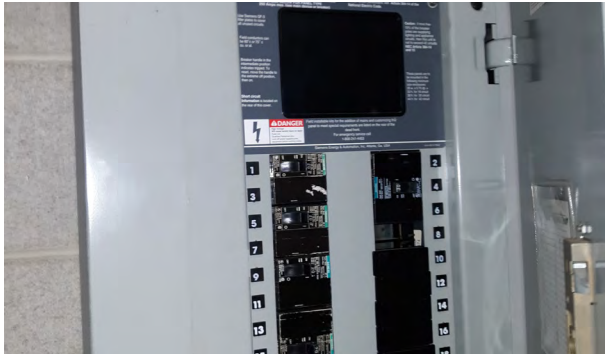
Sub Category	Element	Condition	Priority	Details	Recommendation	Cost Estimate
Power Supply	Dry Room	Poor	1	There is a missing breaker cover in the electrical panel. This is an OSHA violation.	Install a breaker cover.	\$20
Power Supply	Electrical Conduit	Poor	1	There are several areas inside and on the roof where electrical wires are exposed due to damaged conduit.	Replace the damaged conduit.	\$2,700
Power Supply	Main Distribution Panel	Good	3	Main distribution panel is Siemens brand and is rated for 1,600 amps. Panel is original to 1996 construction. The average useful life expectancy is 40 years.	Perform regular maintenance.	\$0
Power Supply	Branch Panels	Good	3	Branch panels are located throughout the building. The panels range in capacity from 150 amps to 250 amps. All branch panels are in good working condition.	Perform regular maintenance.	\$0
Exterior Lighting	Throughout Exterior	Fair	2	There are 14 lights on the exterior that have not been upgraded to LED lighting.	Upgrade remaining areas to LED lighting.	\$3,500

Missing Breaker Cover

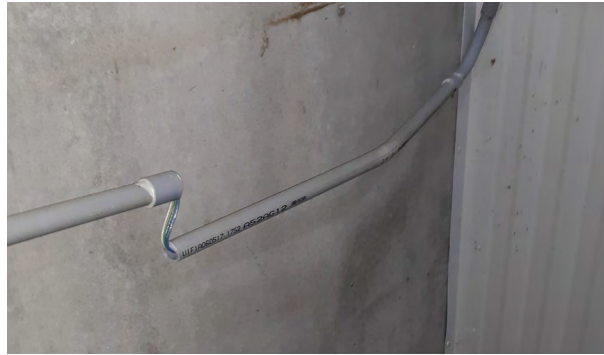
Exposed Wires

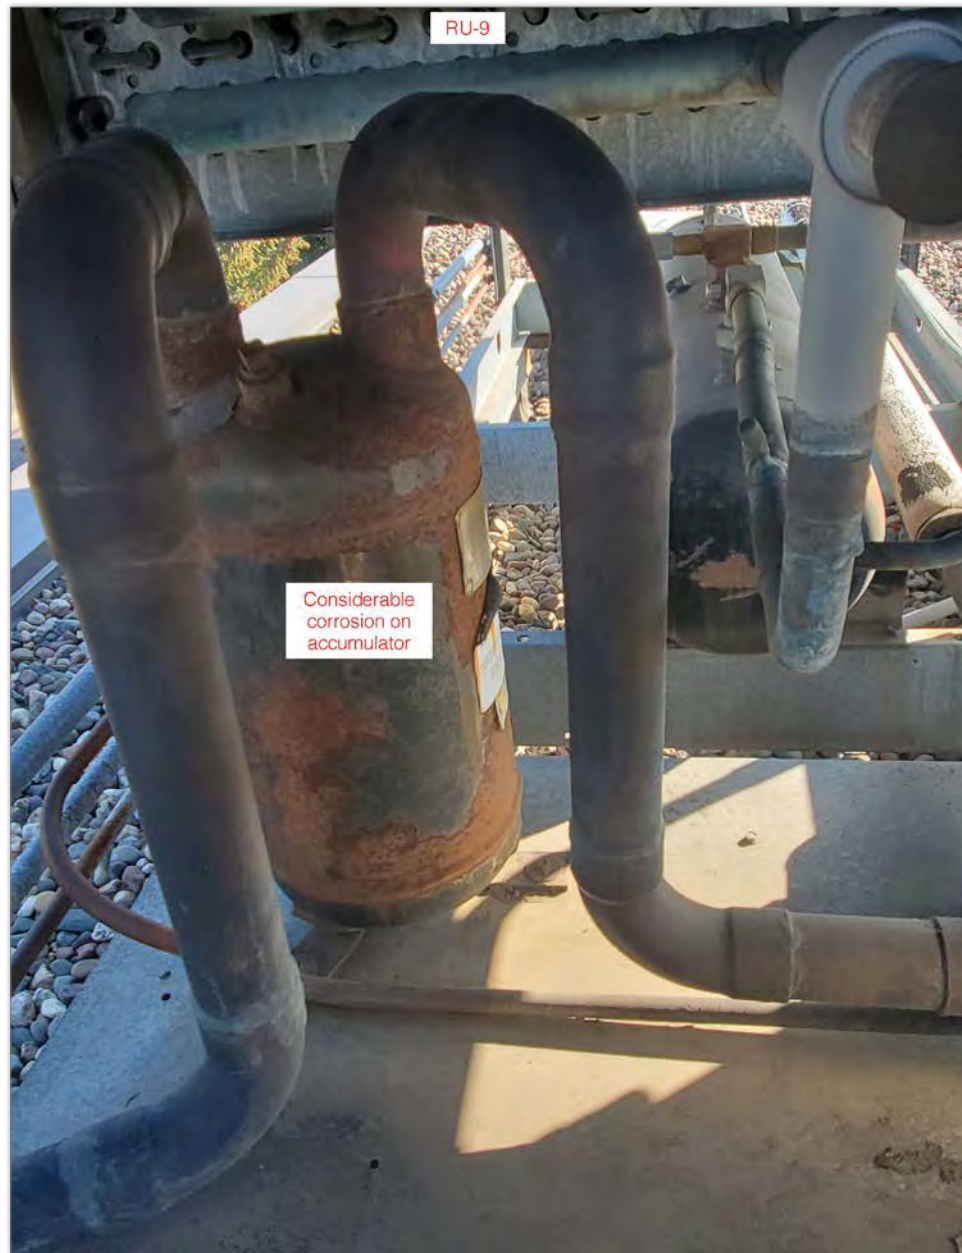
RU-9

Considerable
corrosion on
accumulator

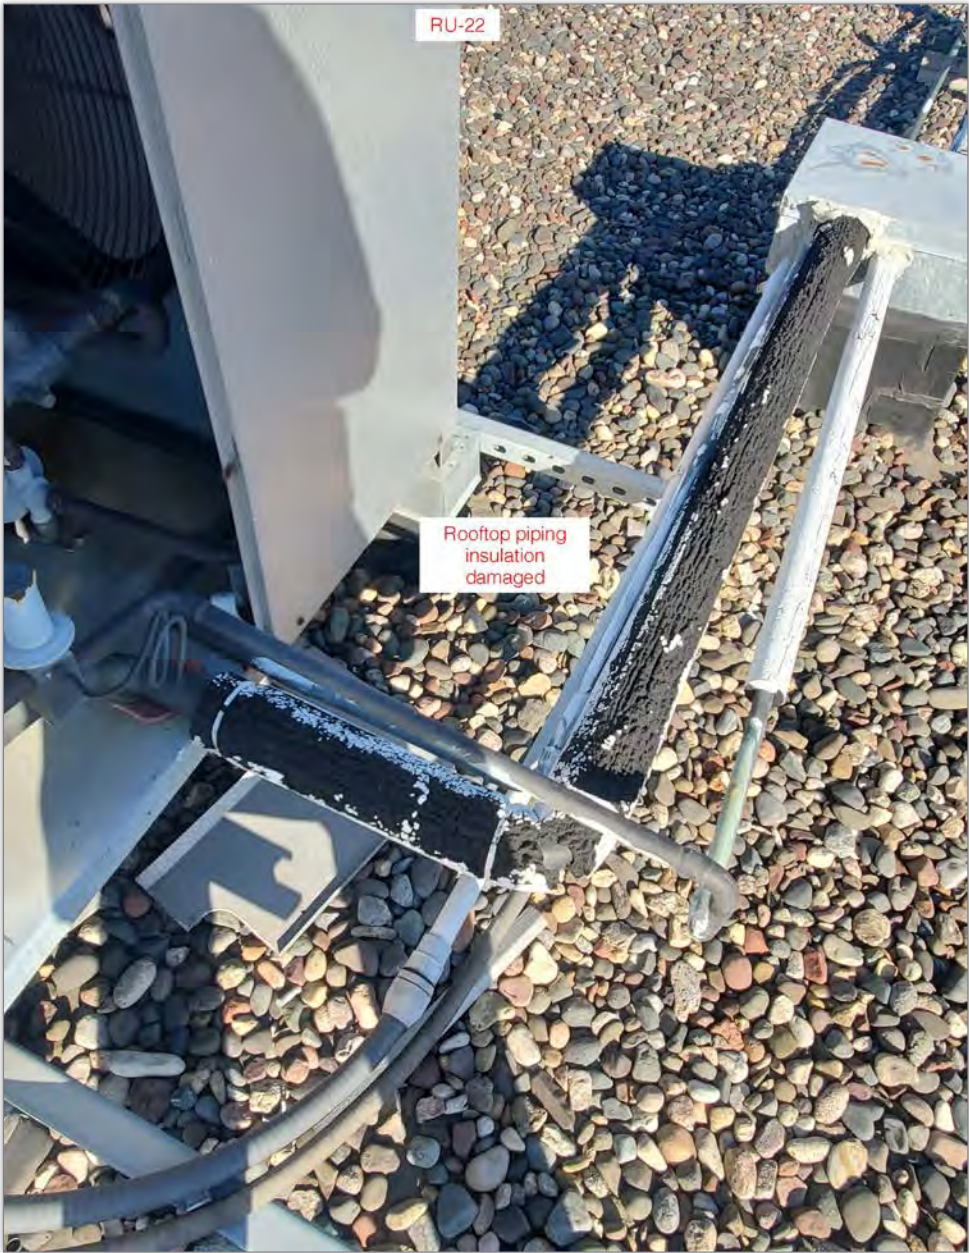
RU-22

Rooftop piping
insulation
damaged
