**Re: Property Condition Assessment Report
Former Bix Produce
1415 L'Orient Street
St. Paul, MN 55117
Nova Project No.: W19-7445**

PROPERTY CONDITION ASSESSMENT REPORT

**FORMER BIX PRODUCE
1415 L'ORIENT STREET
ST. PAUL, MN 55117**

NOVA PROJECT NO. W19-7445

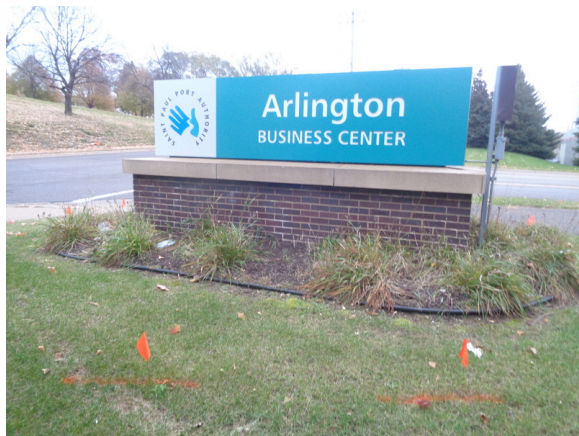
1. Site monument sign.

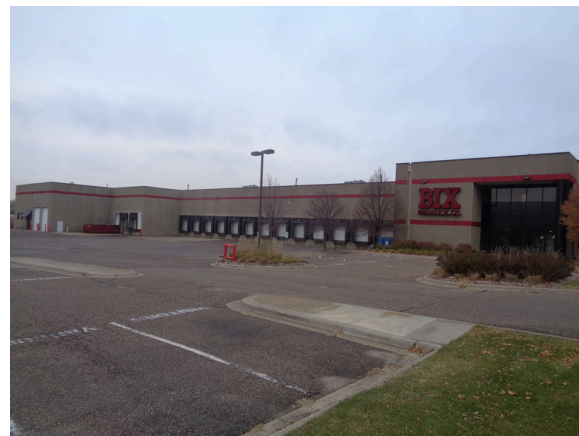
2. South building elevation.

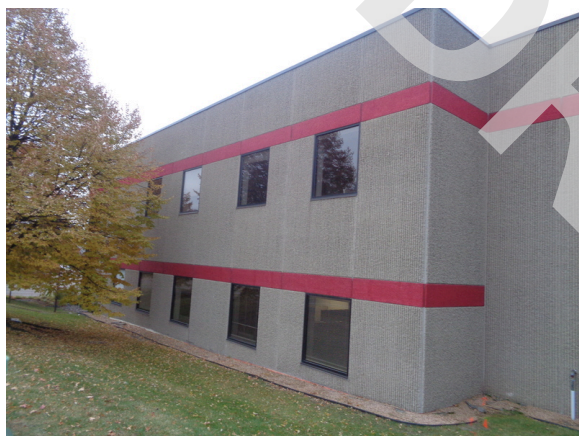
3. Southern portion of east building elevation.

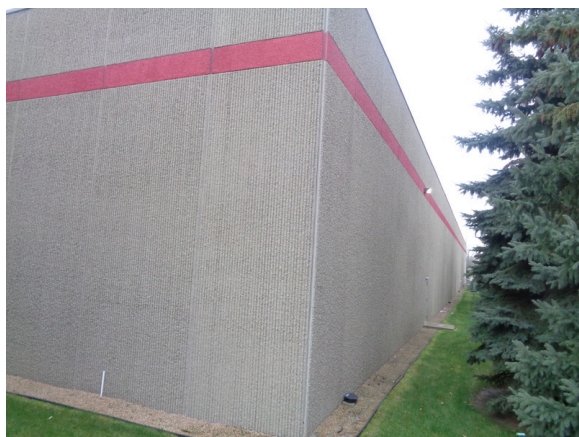
5. North building elevation from the northeast.

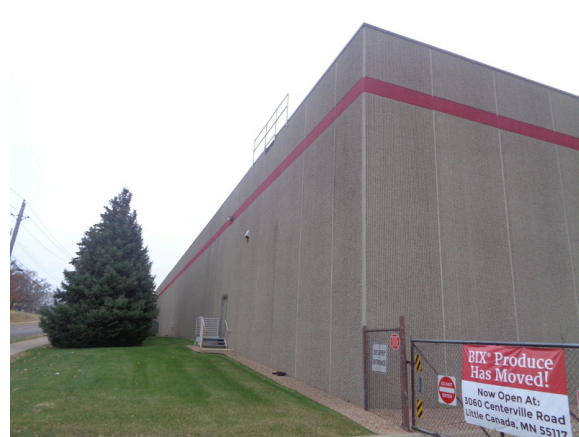
6. North building elevation from the northwest.

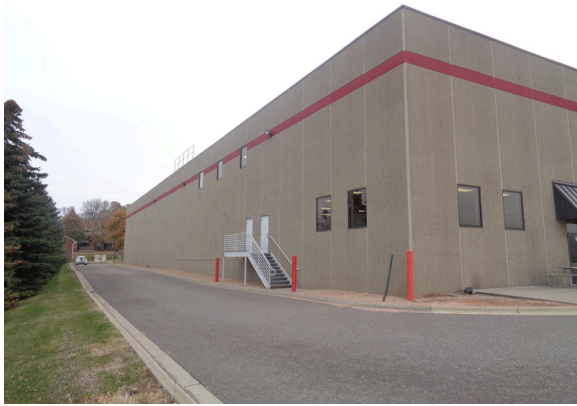
7. West building elevation.

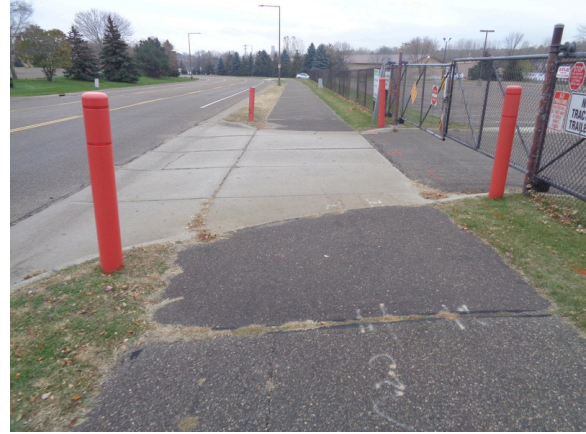
8. East Site entrance.

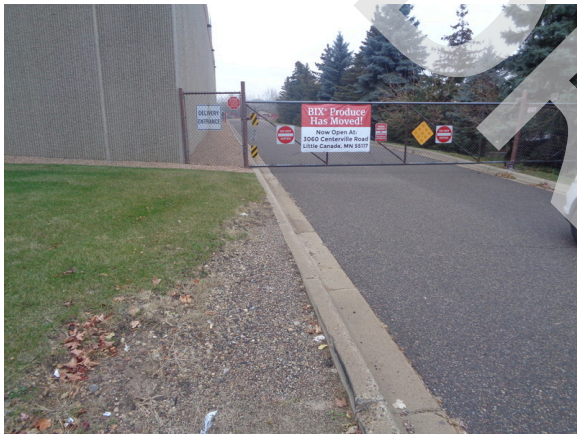
9. Site entrance at the northwest corner.

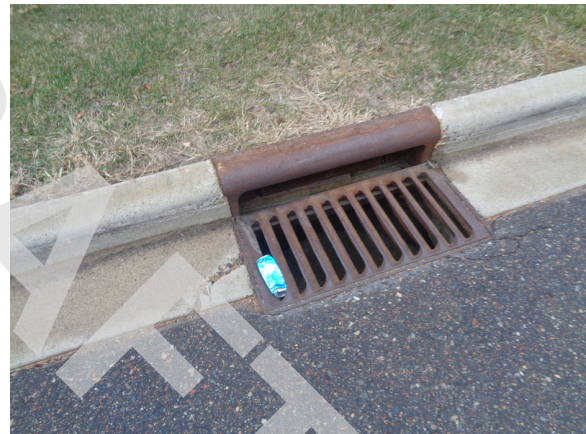
10. Concrete catch basin on west side of Site.

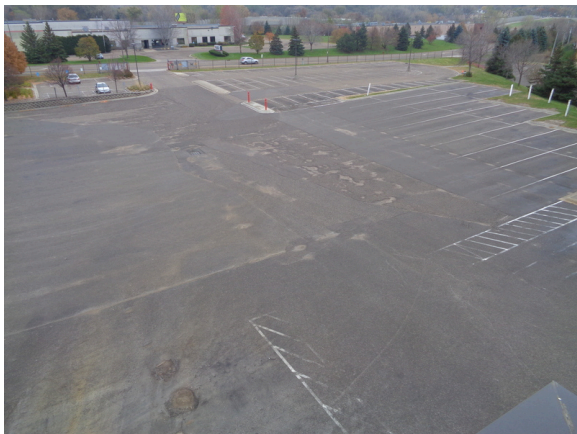
11. Overview of parking area south of the building.

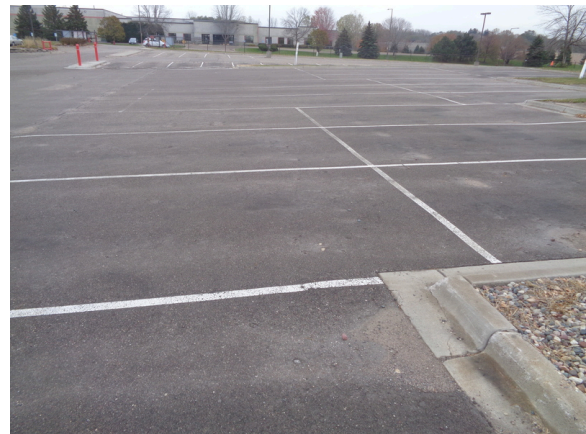
12. Asphalt pavement at truck parking.

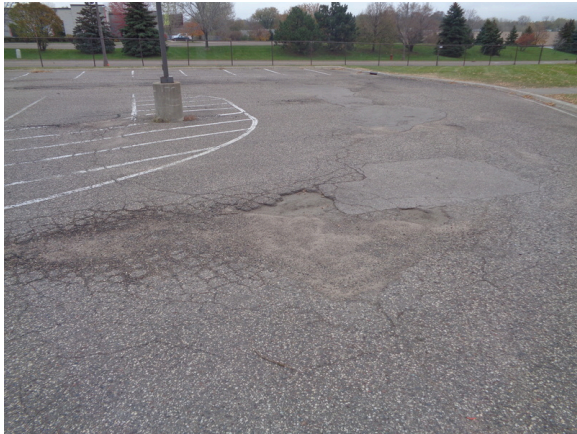
13. Asphalt pavement in car parking area.

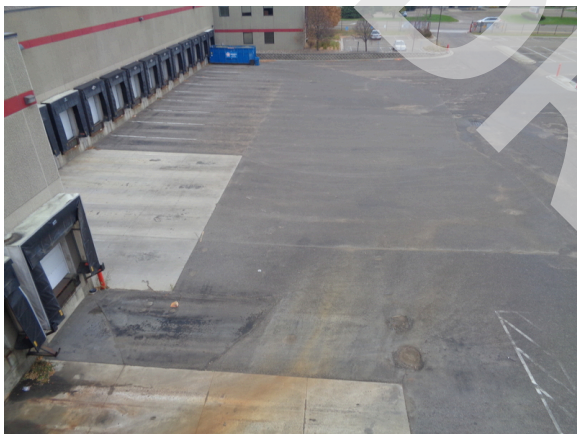
15. Overview of loading dock pavement.

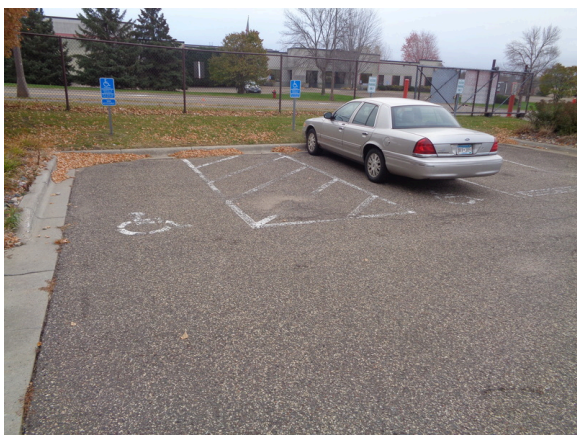
17. Accessible parking spaces.

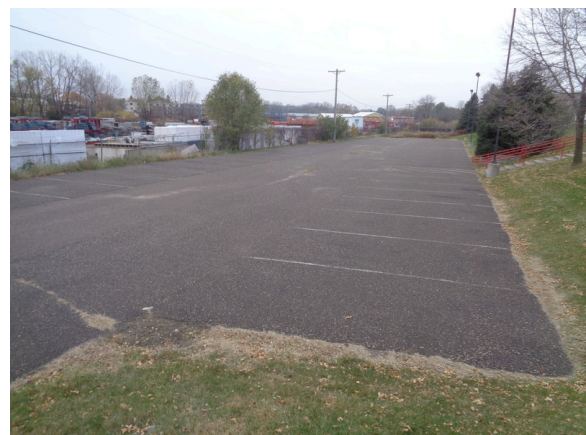
18. Overview of parking area south of the property.

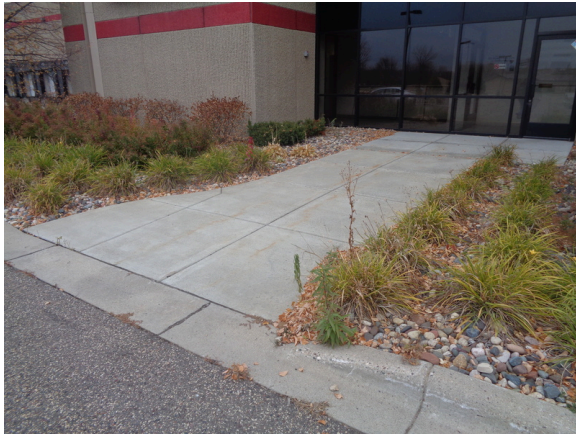
19. Concrete walkway at tenant entrance.

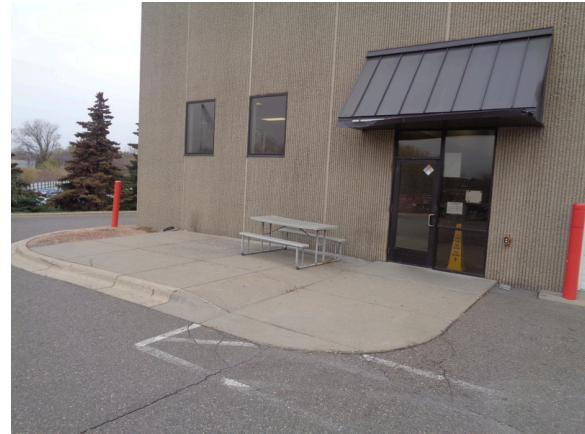
20. Concrete walkway and west entrance.

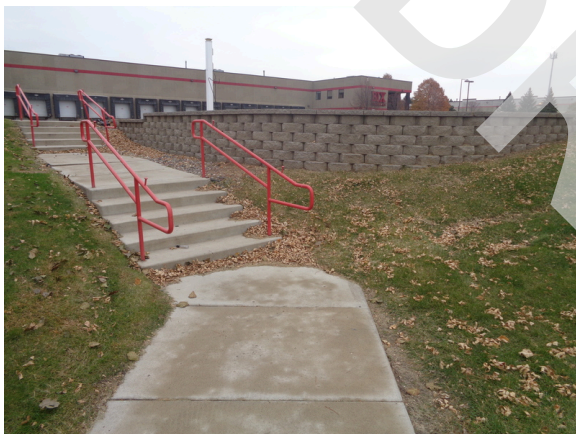
21. CMU retaining wall and concrete stairs at south side of Site.

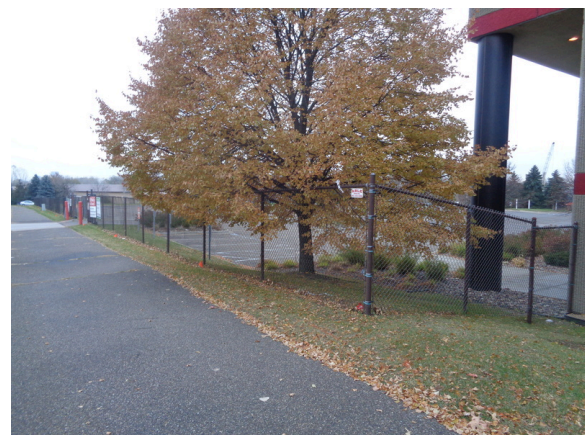
24. Perimeter chain link fencing.

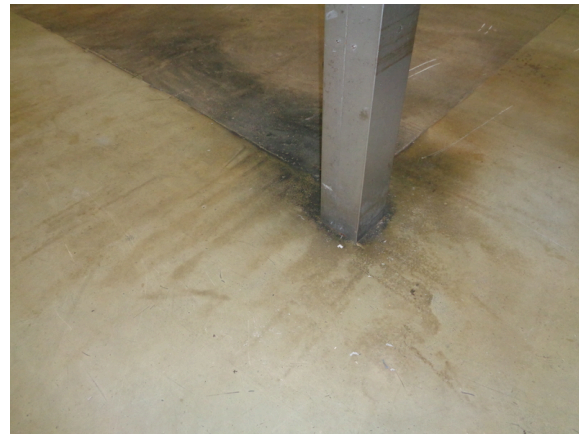
26. Steel column and concrete foundation.

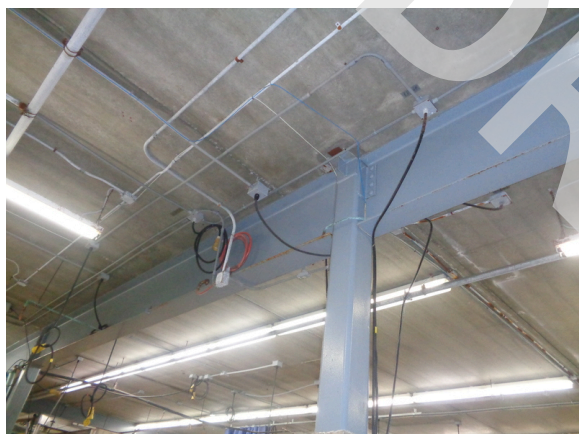
27. Structural steel support and precast concrete panels.

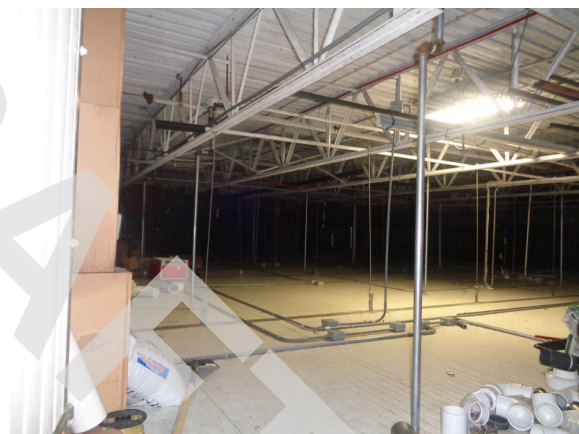
28. Overview of roof structure.

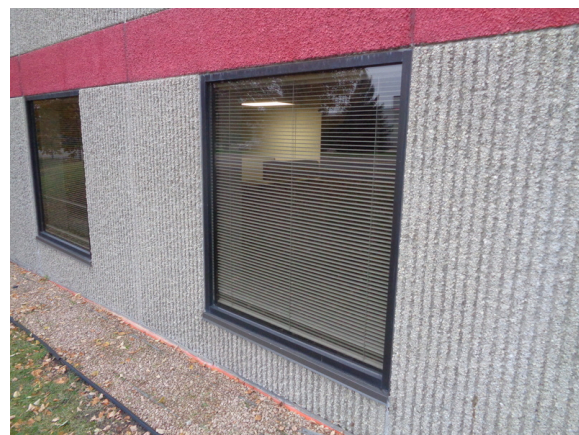
30. Typical window at office space.

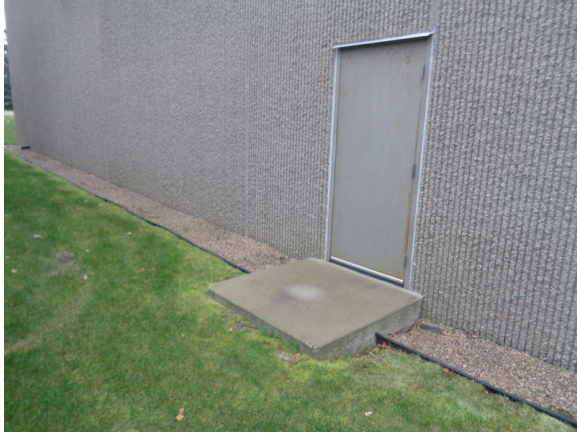
31. Service door and concrete slab.

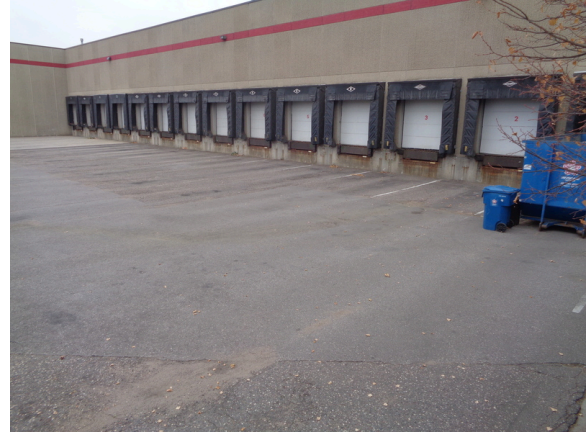
32. Loading docks on south side of building.

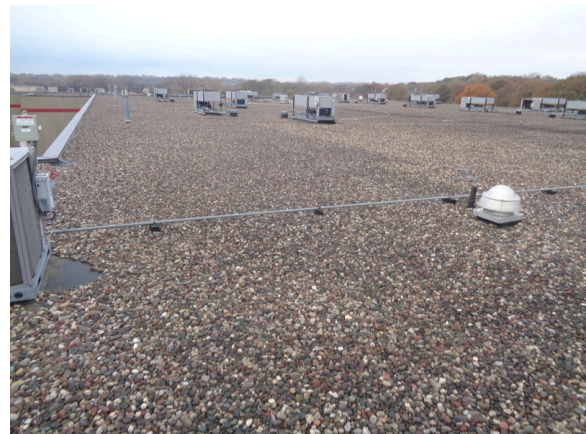
36. Overview of ballasted EPDM main roof.

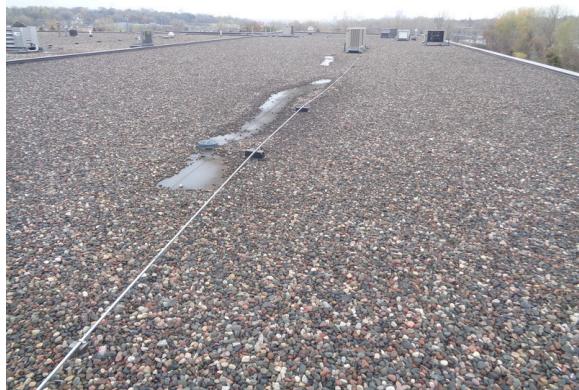
37. Overview of west addition ballasted EPDM roof.

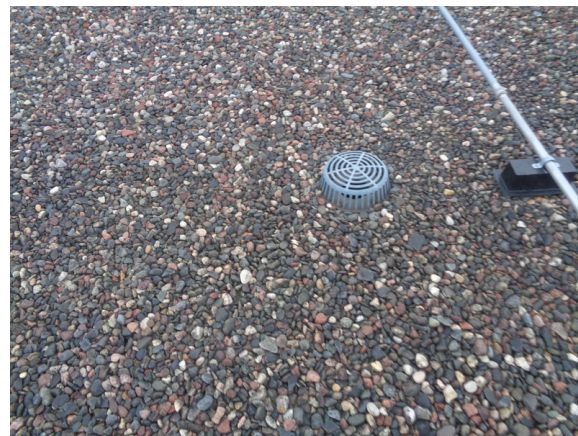
38. Interior roof drain.

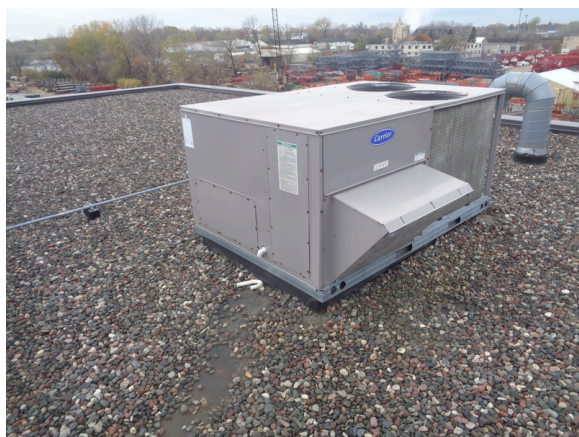
41. Rooftop mounted packaged HVAC unit.

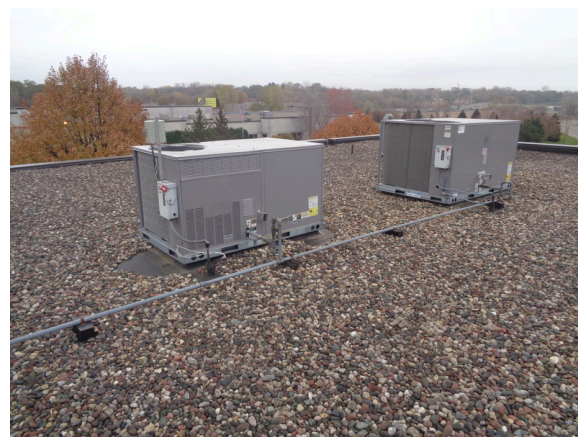
42. Rooftop mounted packaged HVAC units.

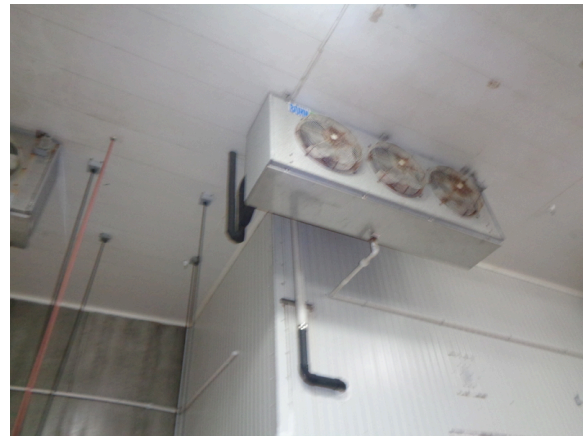
44. Typical cooling unit in refrigerated area.

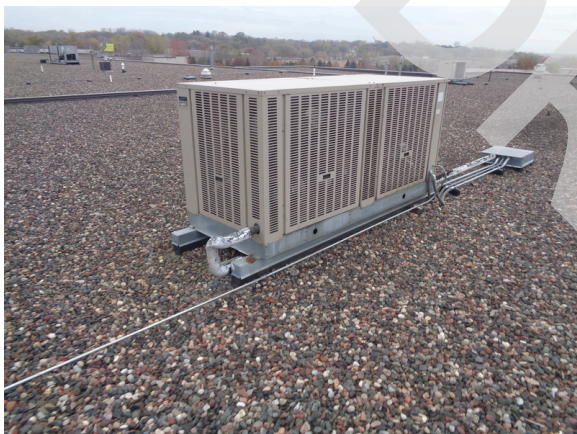
45. Cooling unit roof mounted condenser.

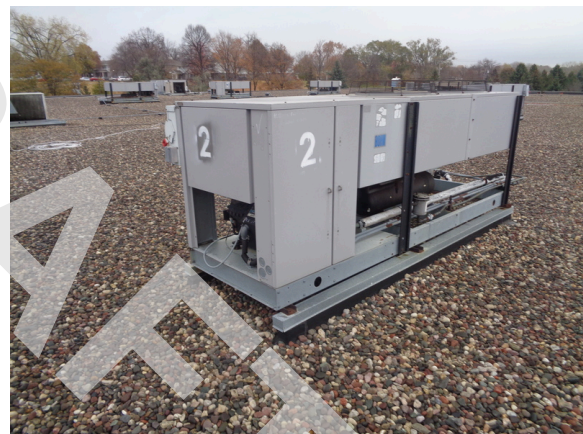
46. Roof mounted cooling unit condenser.

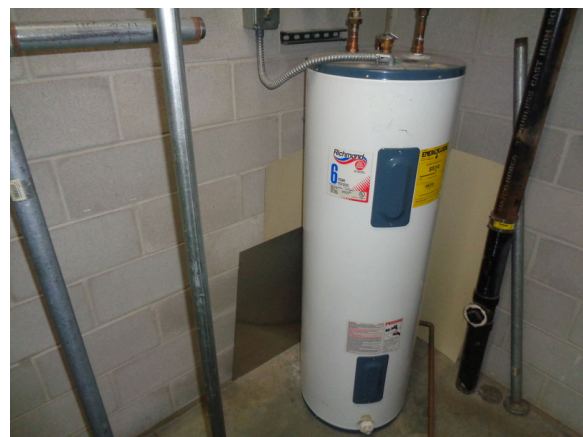
48. Electric water heater for restrooms.

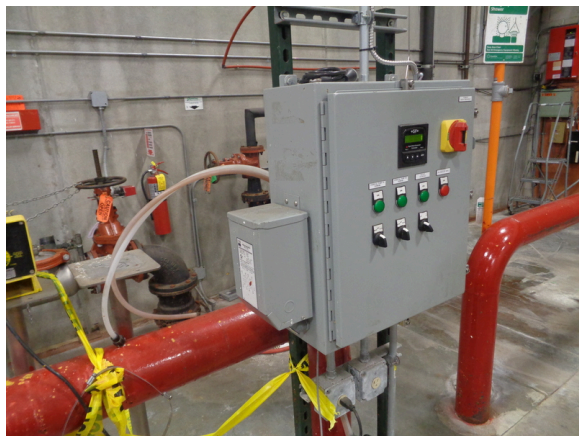
49. Waste water agitation tank controls.

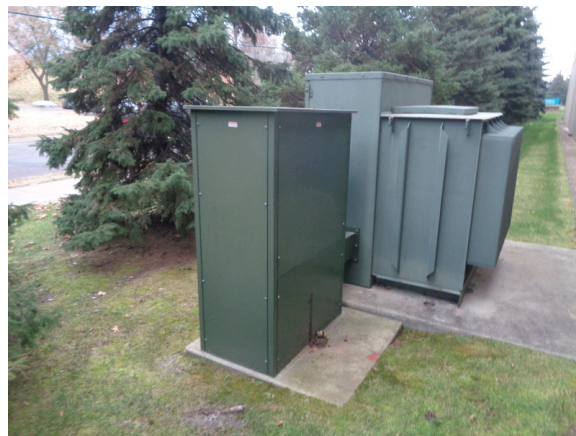
50. Pad mounted electric transformer north of the building.

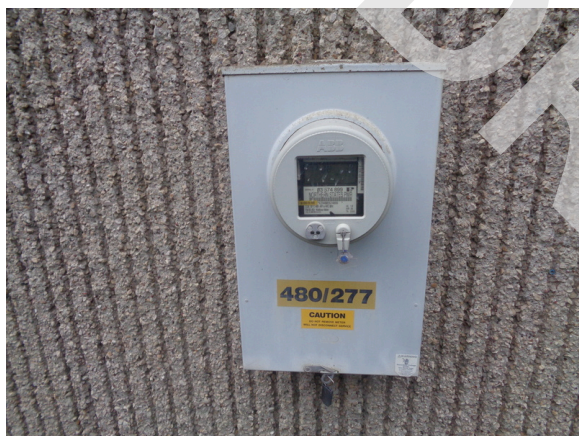
51. Electric meter on building exterior.

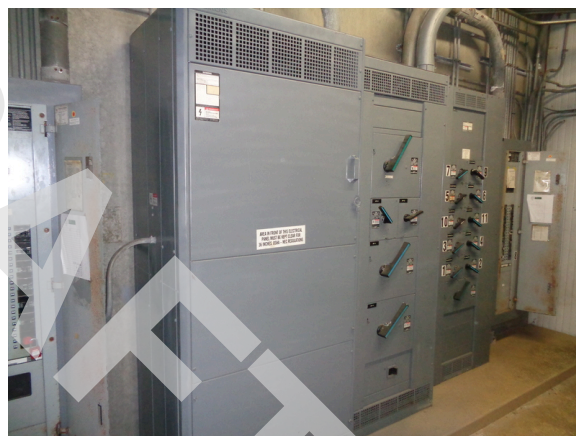
52. Main electrical equipment in electric room.

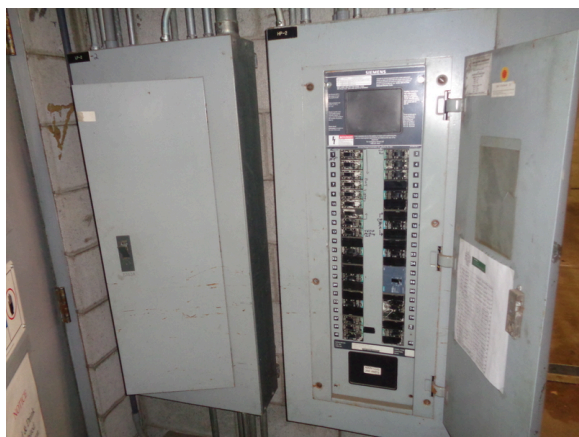
53. Electric subpanel in tenant space.

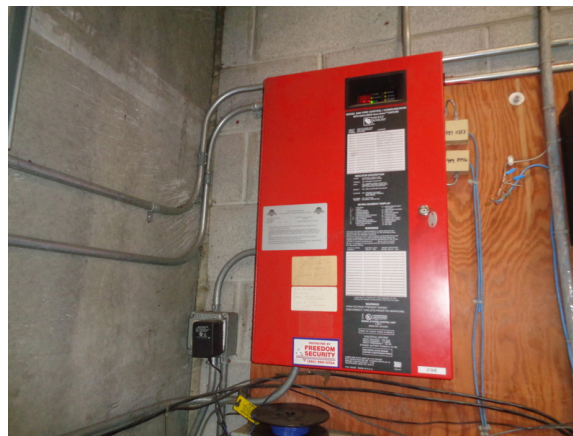
56. Fire alarm control panel.

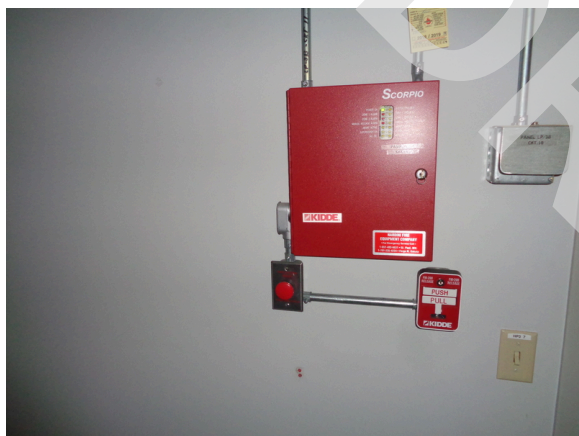
57. FM-200 fire system for server room.

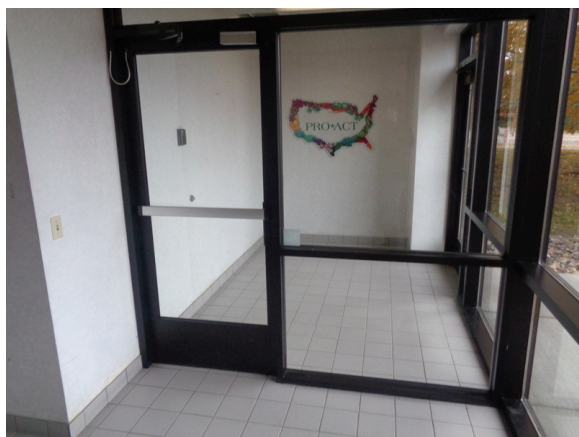
59. Entry vestibule at tenant space.

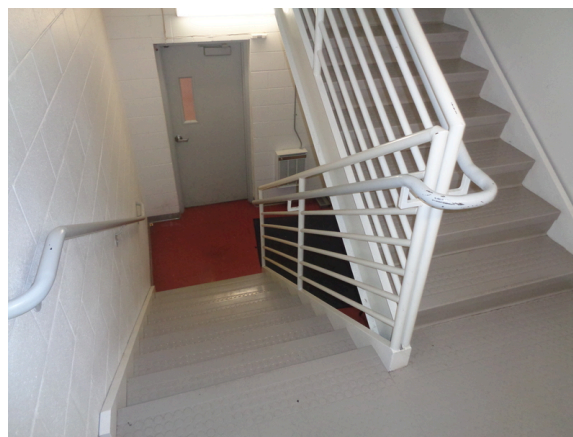
60. Stairwell to mezzanine level.

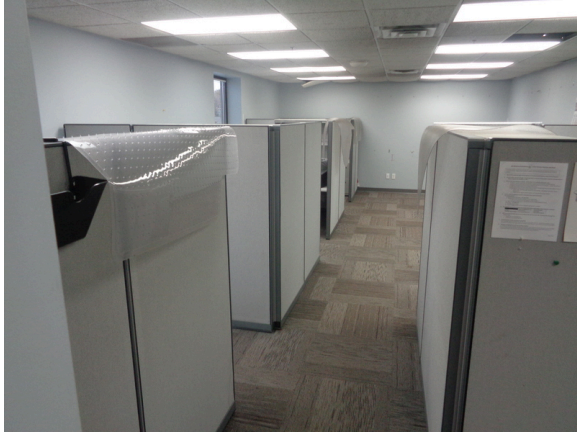
61. Overview of mezzanine level office space.

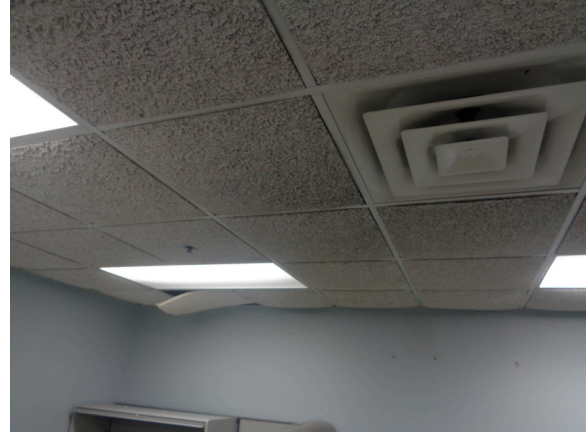
62. Acoustic ceiling tiles in office space.

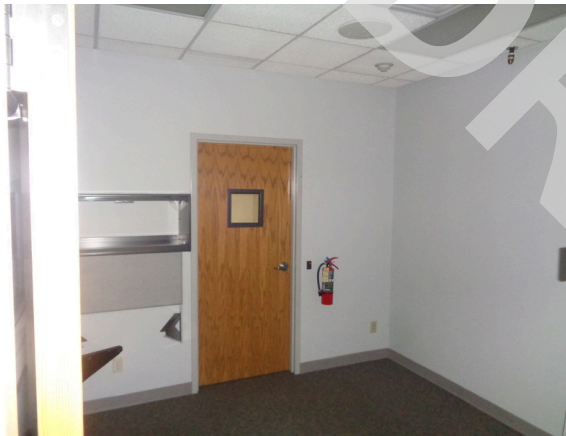
63. Office space finishes.

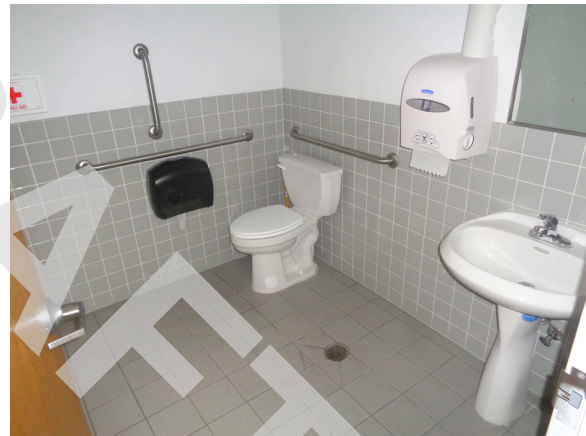
64. Tenant space restroom finishes.

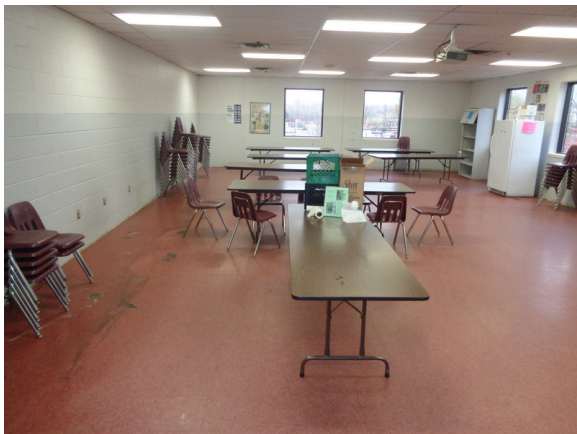
65. Employee break room.

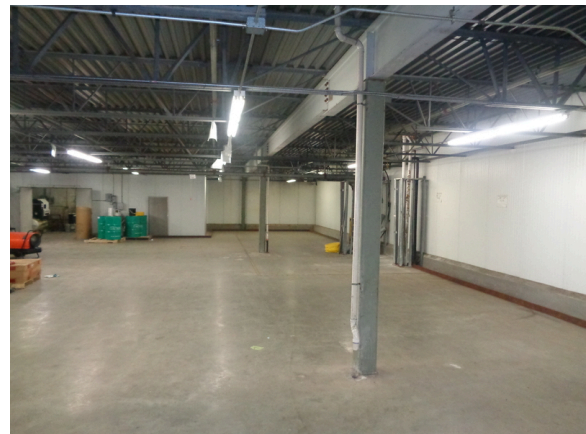
66. Overview of mezzanine level storage.

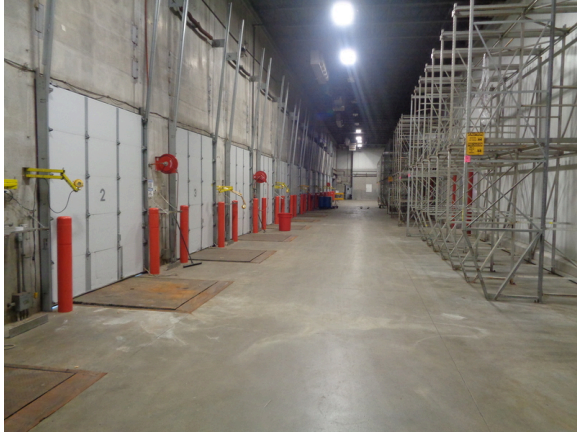
67. Loading dock area in tenant space.

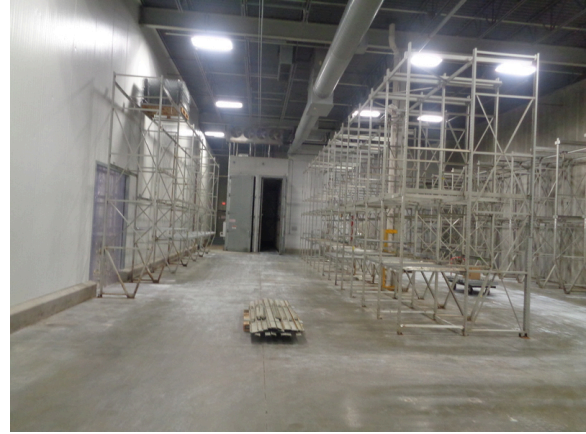
68. Storage area in tenant space.

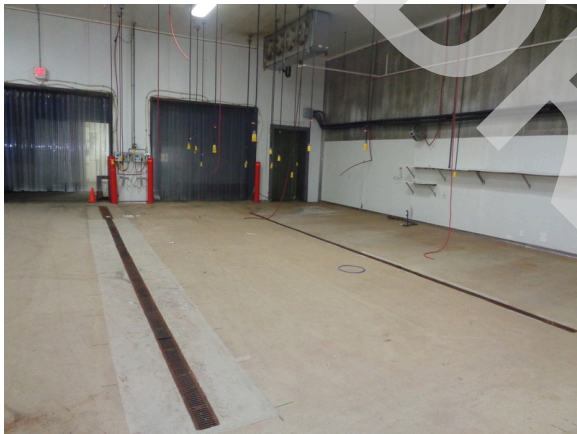
69. Floor drains in refrigerated warehouse.

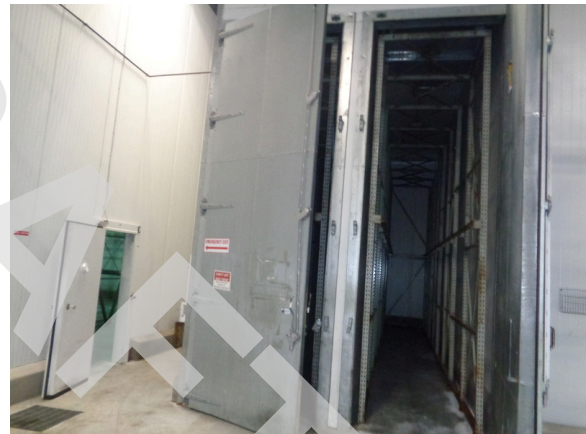
70. Commercial walk-in freezer.
