1415 L'ORIENT STREET

Facility + Refrigeration System Assessment

October 29, 2021

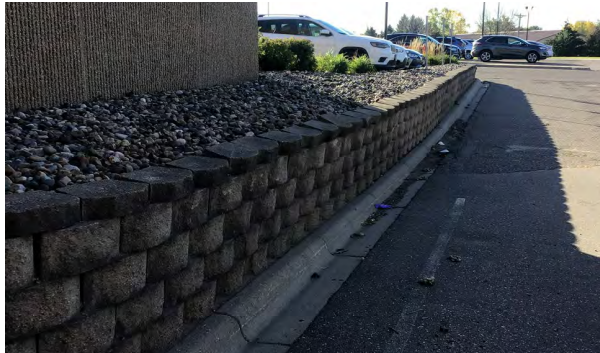
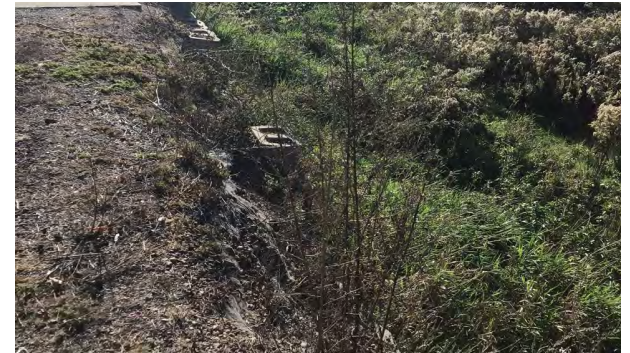
Sub Category	Element	Condition	Priority	Details	Recommendation	Cost Estimate
Grounds + Turf	East Retaining Wall	Poor	I	The retaining wall is significantly curved in the middle section, and slope failure will occur if not corrected.	Remove and replace retaining wall.	\$10,000
Grounds + Turf	West Retaining Wall	Poor	I	The retaining walls have failed and are no longer holding the slopes at all.	Remove and replace retaining wall.	\$14,000
Grounds + Turf	Green-space	Poor	I	Chain-link fence is damaged.	Remove and replace damaged fence posts and chain-link.	\$6,000

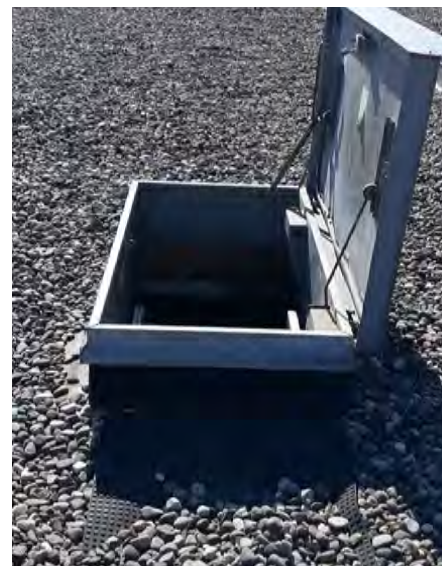
Roof

The original building roof was installed in 1996 and is at the end of its useful life and should be replaced. Portions of the steel roof deck are rusted at varying levels and should also be replaced. In addition, where the roof deck is exposed inside of a cooler or freezer, the deck and bar joist should be protected from condensation so rusting will not occur. Secondary roof drains will be required when installing the new roof section. The exterior walls of the building are in good shape overall, but do require resealing the precast panel connections. There is minor damage of the precast walls at the loading dock doors.

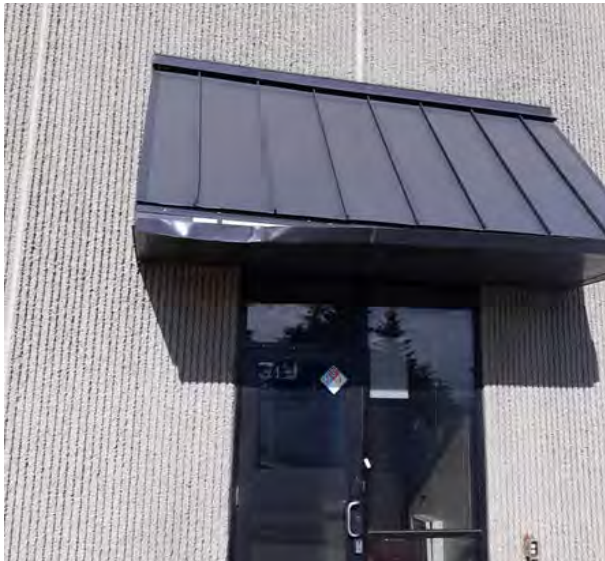
Sub Category	Element	Condition	Priority	Details	Recommendation	Cost Estimate
Exterior Doors	Overhead Doors	Fair	I	Overhead door seals in some locations are damaged or missing. Several of the doors do not stay in the raised position.	Replace door seals. Adjust springs and lubricate rollers.	\$16,000
Exterior Doors	Steel Exit Doors	Poor	I	Several of the steel exit doors and frames are rusted and do not operate correctly.	Replace four of the six exit doors, frames, and hardware.	\$21,500
Exterior Doors	Office Entrance	Good	3	Door and windows are aluminum framed, double paned glass.	Perform regular maintenance.	\$0
Exterior Doors	Employee Entrance	Fair	2	Door and windows are aluminum framed, double paned glass. The door is rubbing on frame.	Adjust door.	\$200
Exterior Doors	Employee Entrance Canopy	Poor	I	The canopy sheet metal and rain gutter are damaged.	Repair damaged portions of the canopy.	\$1,000

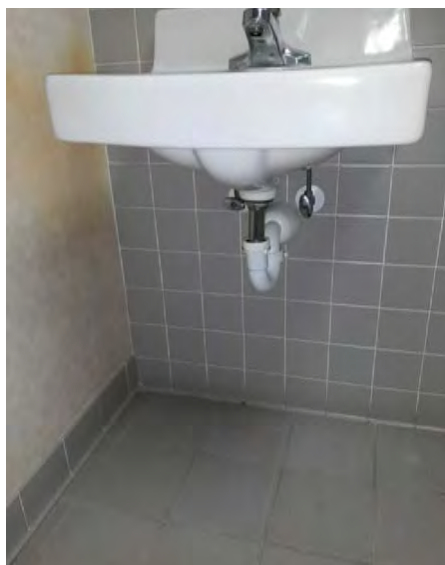
Office Carpet

The carpet and acoustical ceiling tiles are in poor condition in the office and break room areas. The walls are outdated and should be refinished as well. Several of the lockers are damaged caused by rust in the locker room. It is recommended the locker system be replaced.

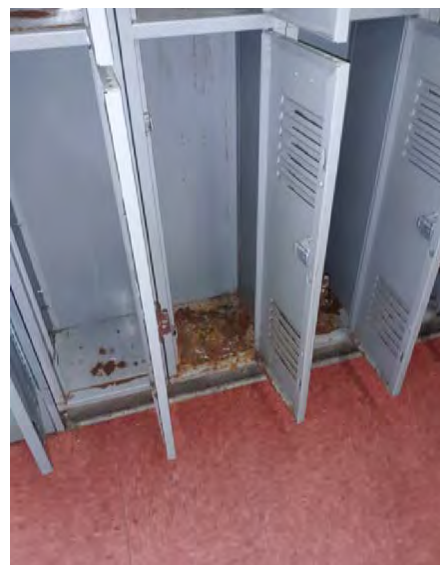
Locker Room Lockers

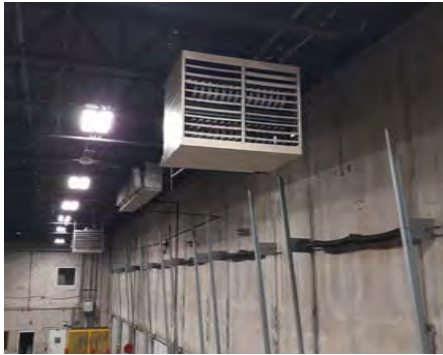
Unit Heater

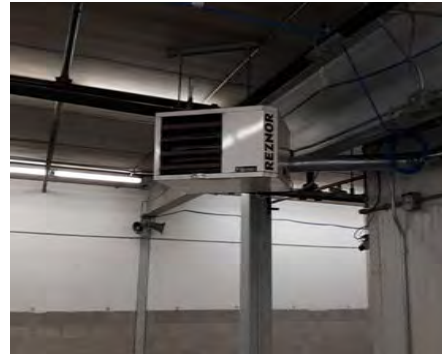
Ceiling Mounted Heaters

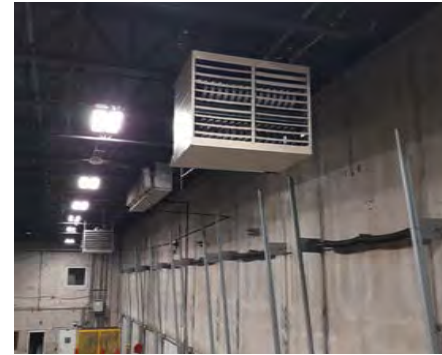
Ceiling Mounted Heaters

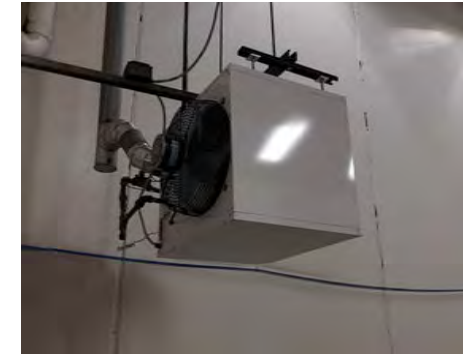
Ceiling Mounted Heaters

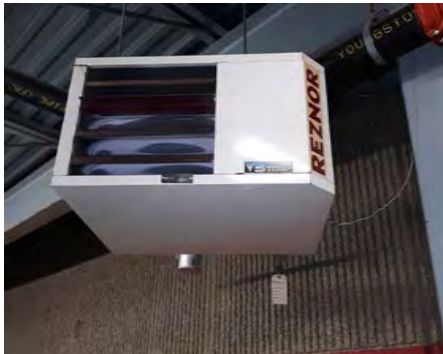
Ceiling Mounted Heaters

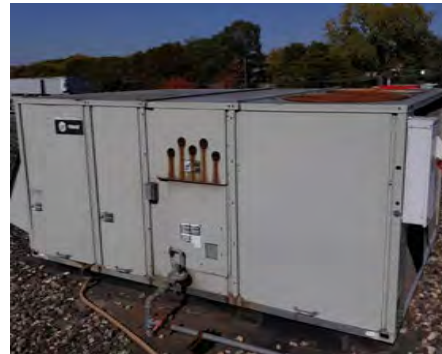
Rooftop Unit

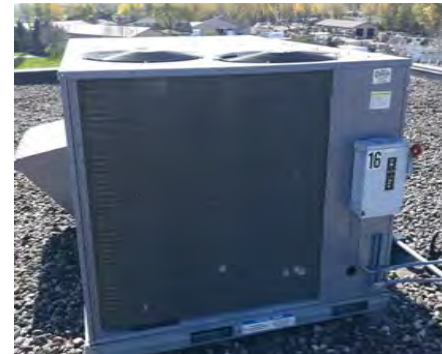
Rooftop Unit

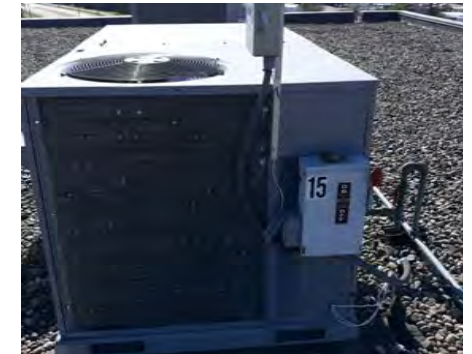
Rooftop Unit

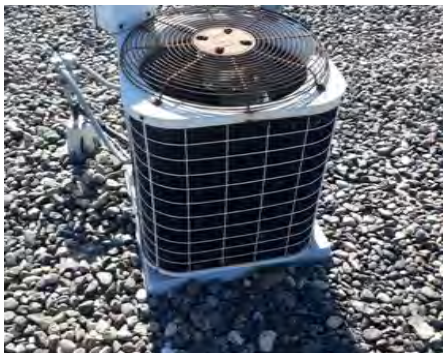
Condensing Unit

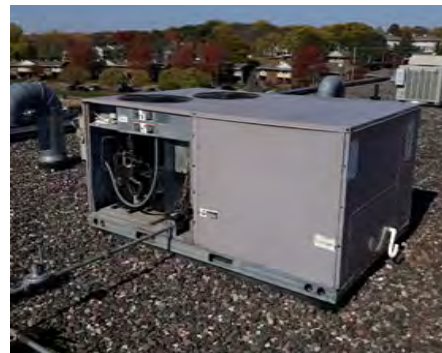
Rooftop Unit

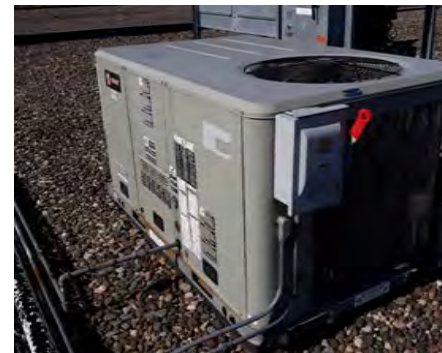
Rooftop Unit

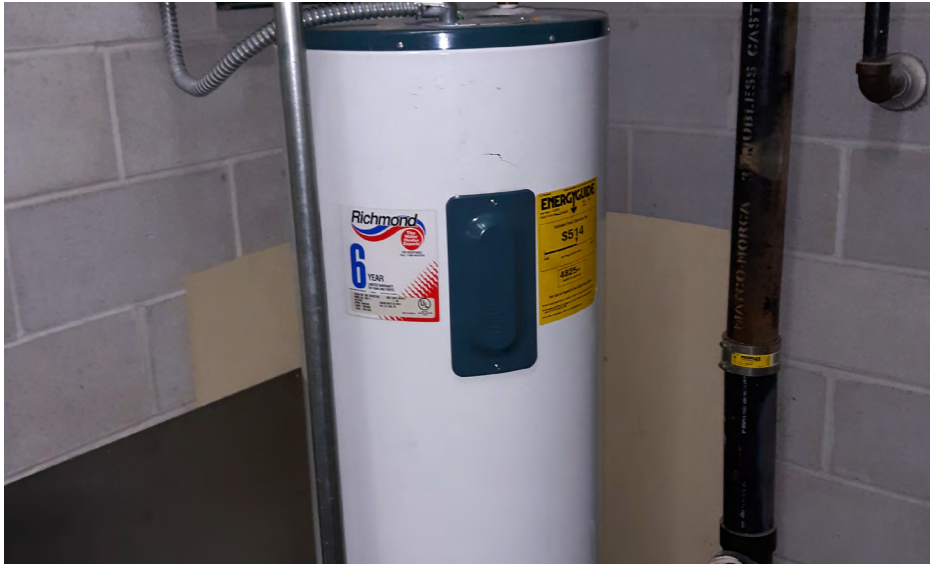
Water Heater

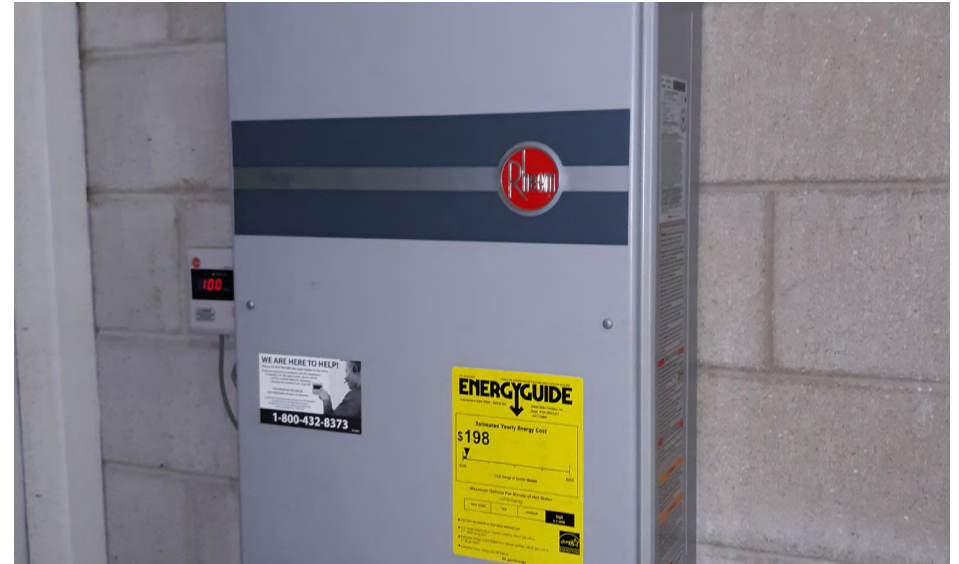
Water Heater

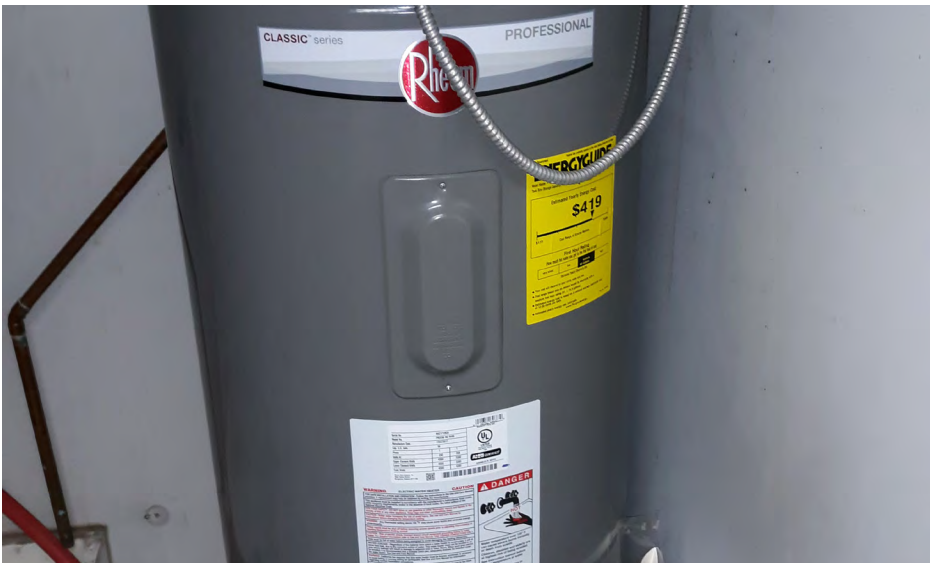
Water Heater

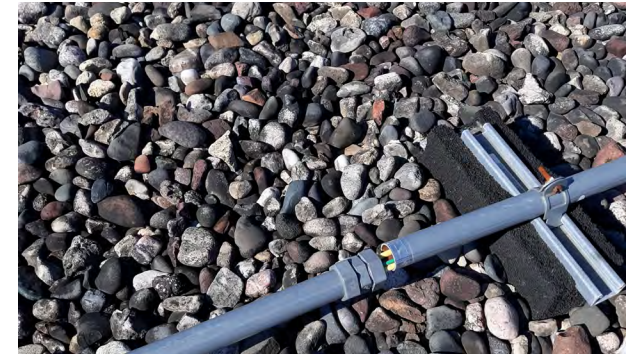
Exposed Wires

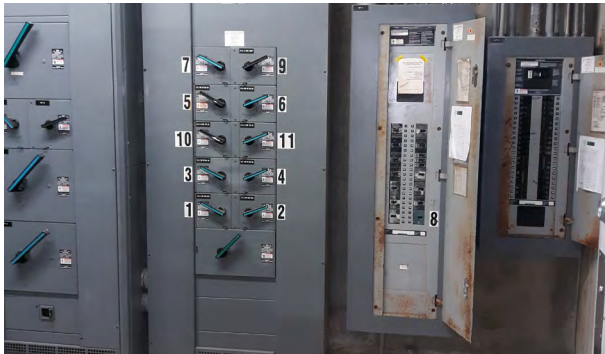
Main Electrical Panel

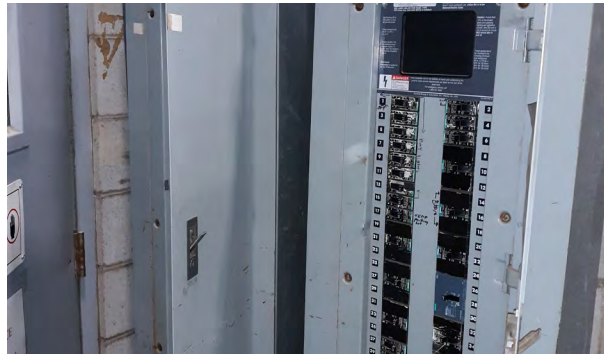
Branch Panels

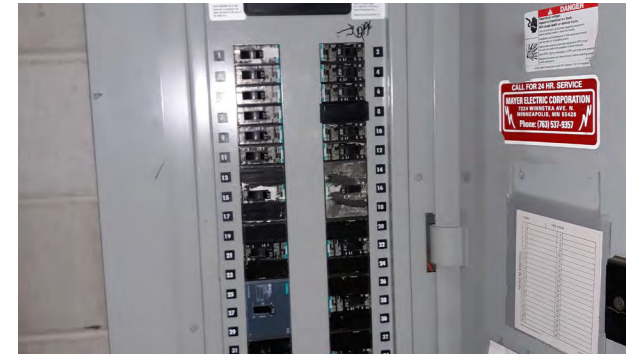
Branch Panels

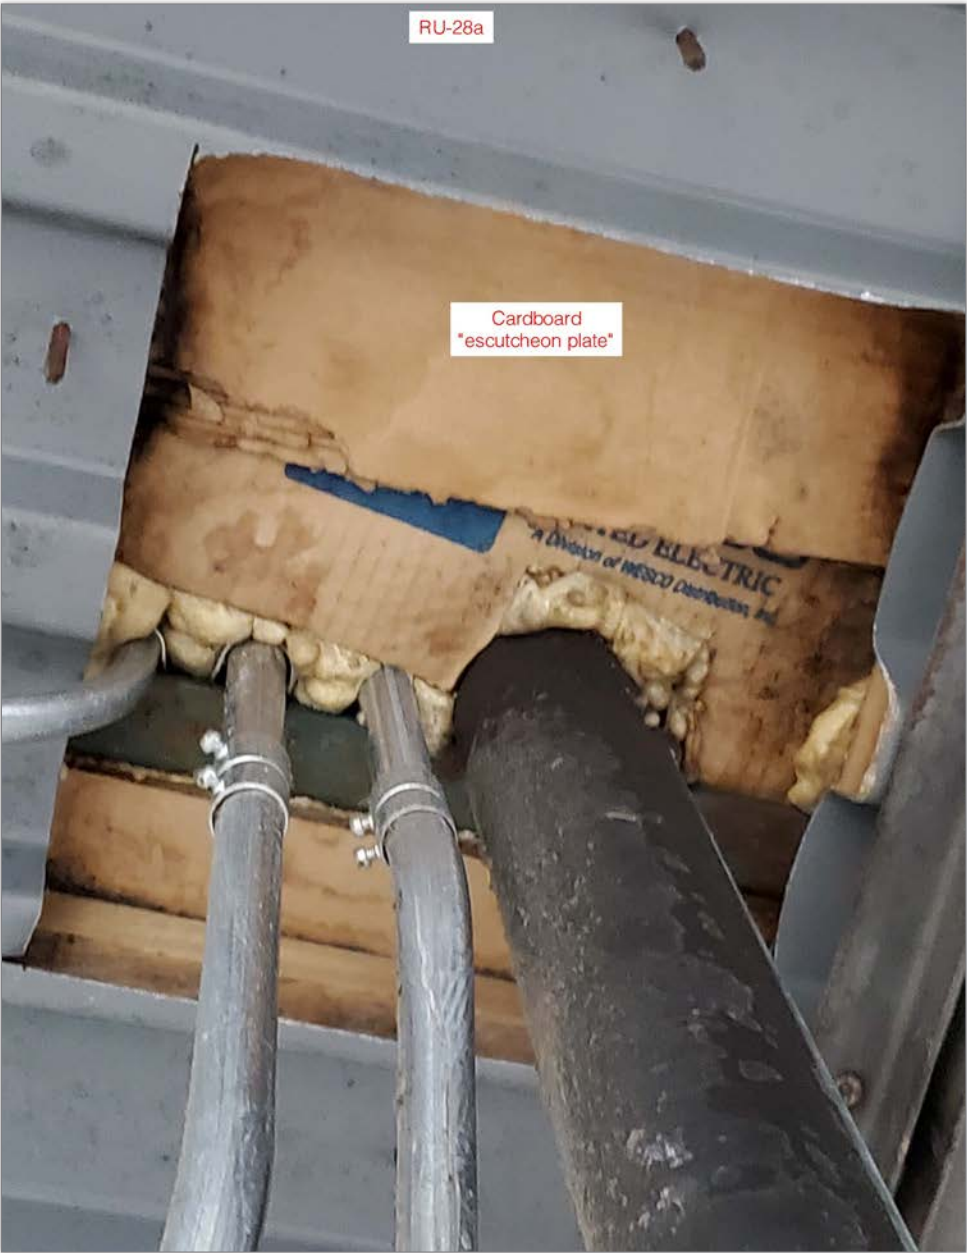
RU-28a

Cardboard
"escutcheon plate"
